GARRM, Prague, September 2021

## **Long-term study of radon concentration dynamics in a four-storey building**

Location: Estonia, Tallinn city;

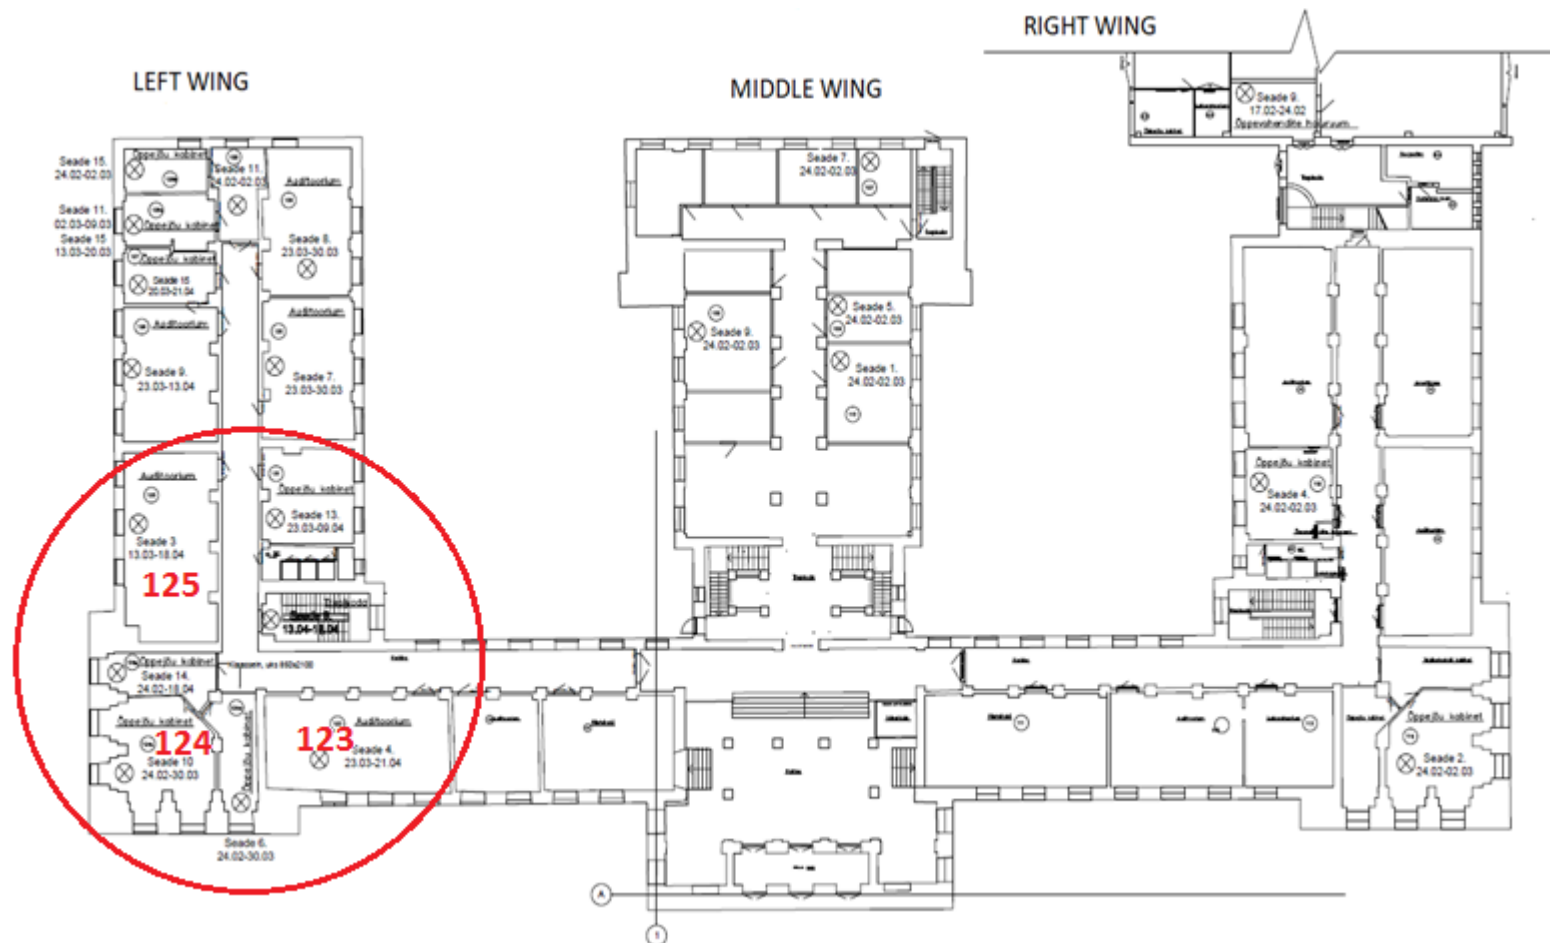
## First Floor Building Plan

According to the building's ventilation plans, vertical ventilation shafts pass through the floors of the building. Along these shafts, radon can move from the lower floors to the upper floors and enter the rooms through the ventilation ducts. Radon-transmitting cavities can be located in the pillars passing through the building, which are built as hollows inside. As it is relatively old building, old technical system shafts and/or pipelines, that are no longer used and have not been closed or removed, may pass through the building.

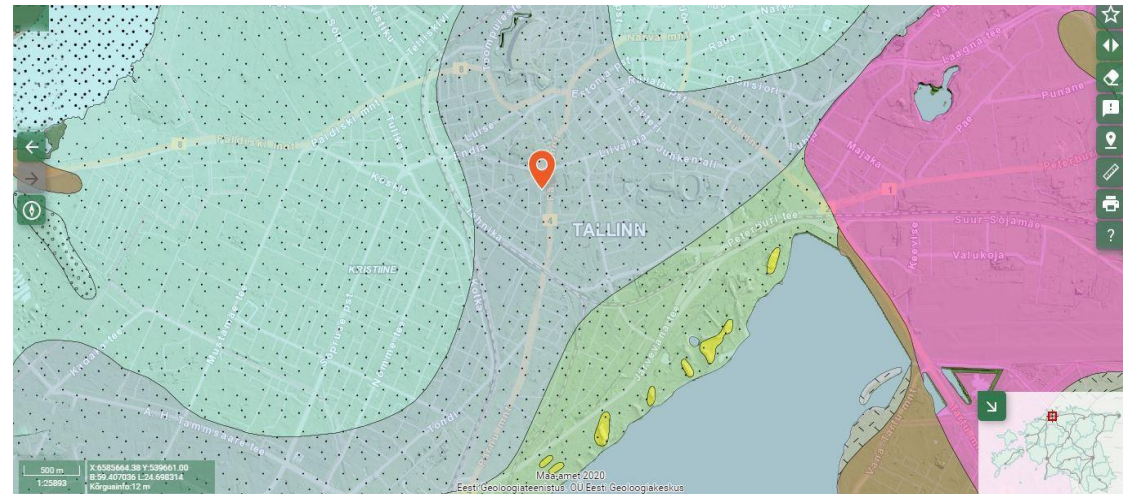
Surface coating map shows different sediments of Littorina Sea period. Therefore building is located on marine sediments (blue color on the map), which contain gravel, sand, silt, sandy clay, aleurite, loam, bay muds. In addition, these sediments contain variable quantity of graptolitic argillite and phosphorite crushed pieces, which are the main source of radon; radon air can migrate into the building from the surface soils.

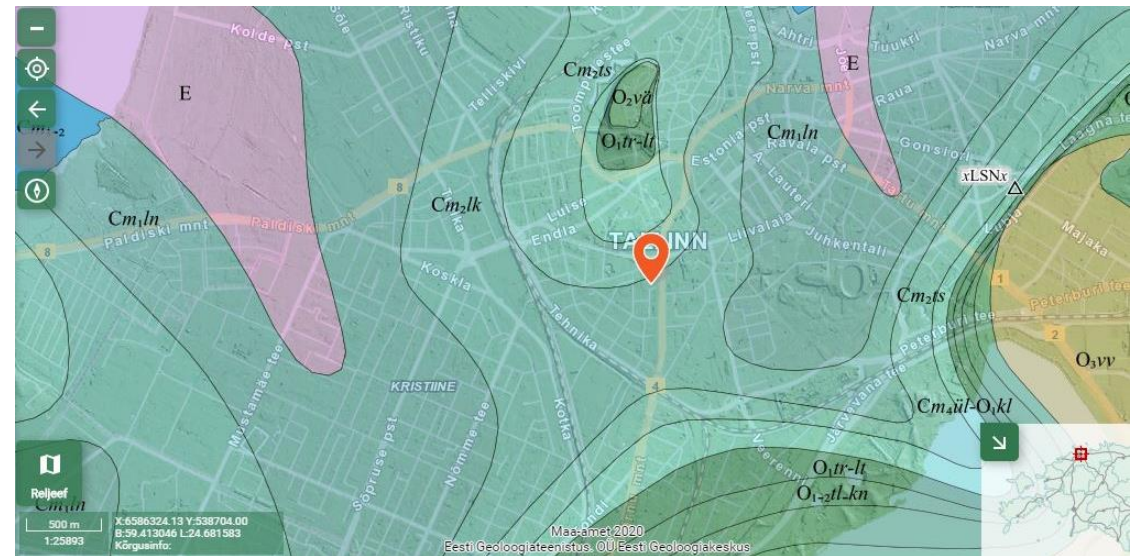
Geological Bedrock map shows that there are many Cambrian rock layers and rock types for different geological ages at the building area, which are lying under the surface soils. Two nearest formations are  $Cm_2lk$  and  $Cm_2ts$ :

$Cm_2lk$  – basic formation under the building, Early Cambrian formation (local name Lükati formation) thickness is 7–16 m, it contains blue clays, where aleurite clay content is dominating ~60–70%, and it also contains fine-grained quartz sandstone layers.

$Cm_2ts$  - Cambrian Series formation (local name Tiskre formation) thickness is 16–21 m and thickness is constant, is represented by fine-grained, weak- to medium-cemented light grey quartz sandstone of the Early Cambrian or coarse-grained quartz aleurite. Sandstone contain glauconite clay with aleurite layers.

As a result, it can be concluded that the building is located on high radon risk area; because there are formations containing phosphorite, graptolite-argillite

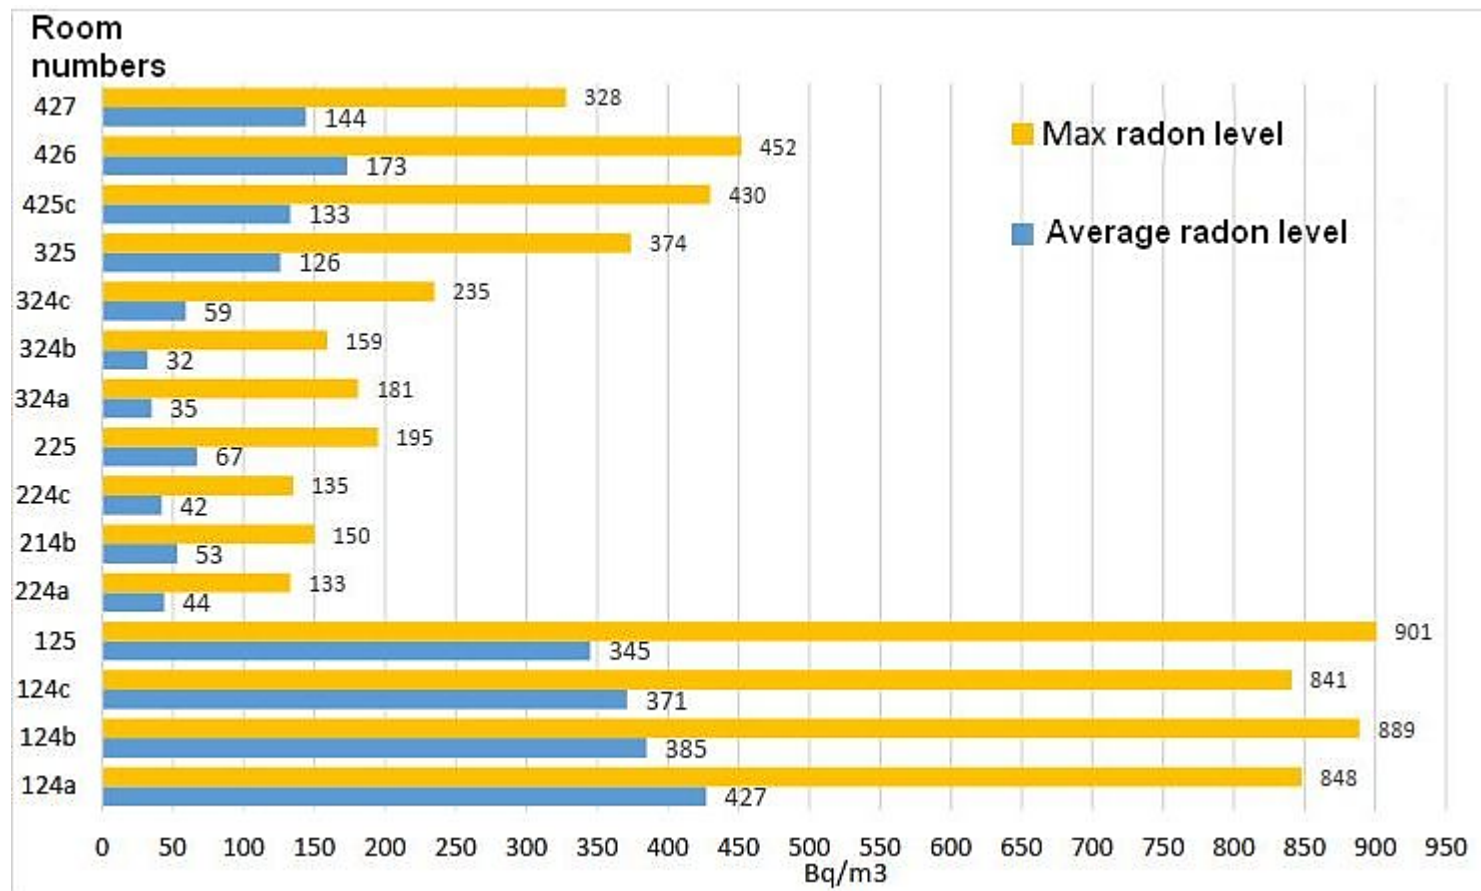
# Results of one week measurement

- For indoor radon measurements RadonEye Plus2 detector devices were used.
- RadonEye Plus2 total readings in the radon chamber during 20 days comparison differed by less than 3.5% from AlphaGuard total readings.
- In spring 2020, one-week measurements of radon activity concentrations were carried out on all floors of the building at homogeneous zones.
- The results of this study showed an increase in radon mean activity concentration values in the left-wing rooms of the building.

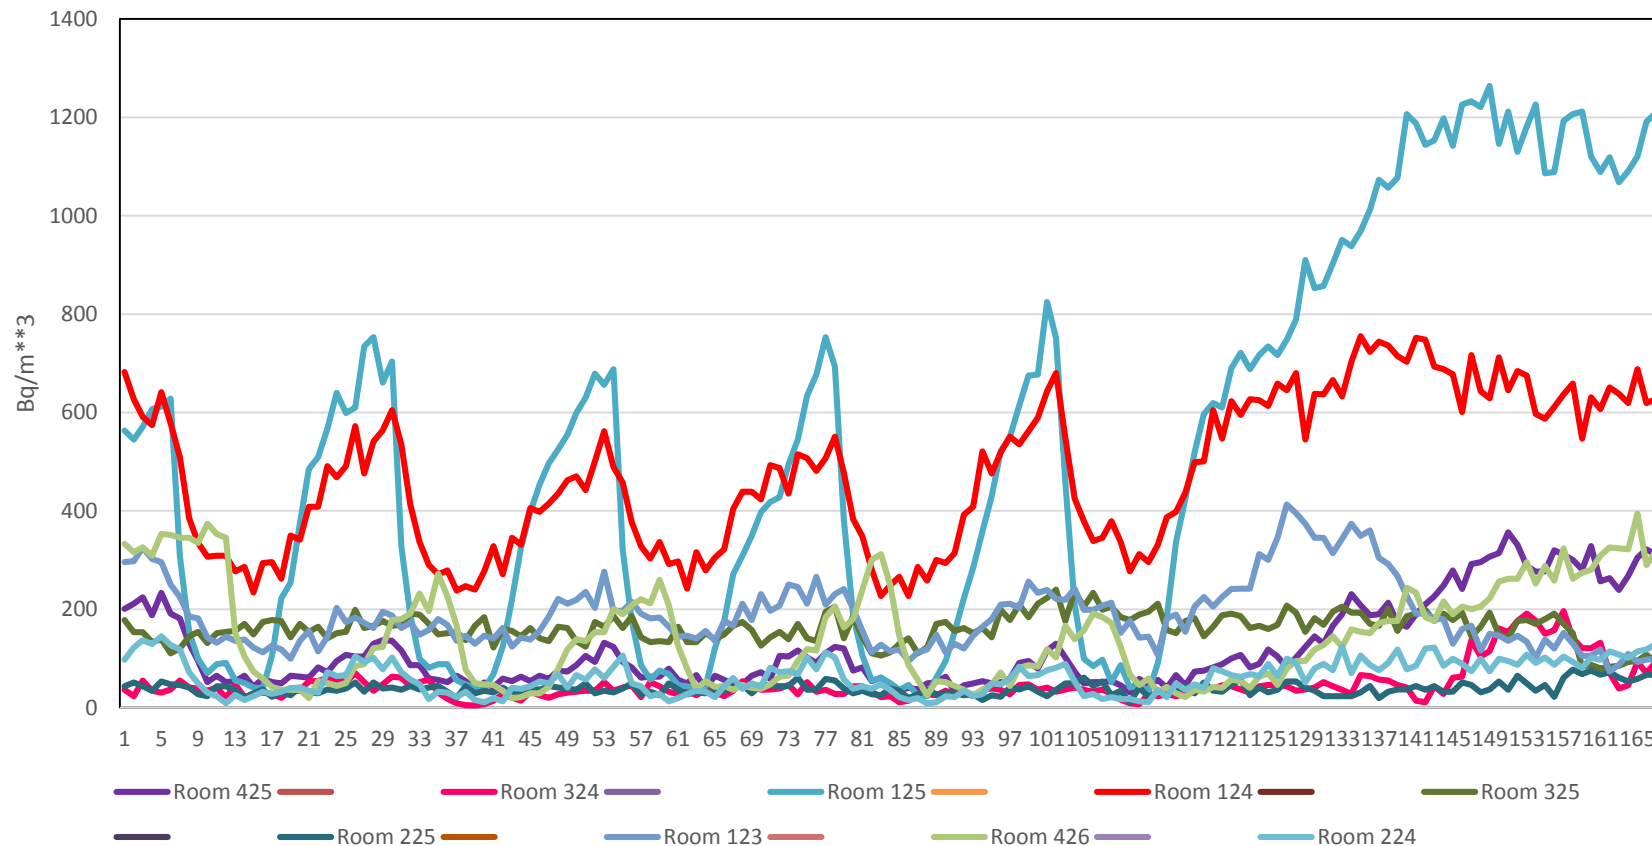
## Typical one week pattern

One week 20.04.2020...27.04.2020
