# Case studies (RADOIL project pilot sites)

Measurement of radon in soil gas as an indicator of contamination by petroleum substances

RADOIL - Measurement of radon in soil gas as an indicator of contamination by petroleum substances

**Methodology for indirect  
measurement of oil contamination  
using the natural tracer Rn**

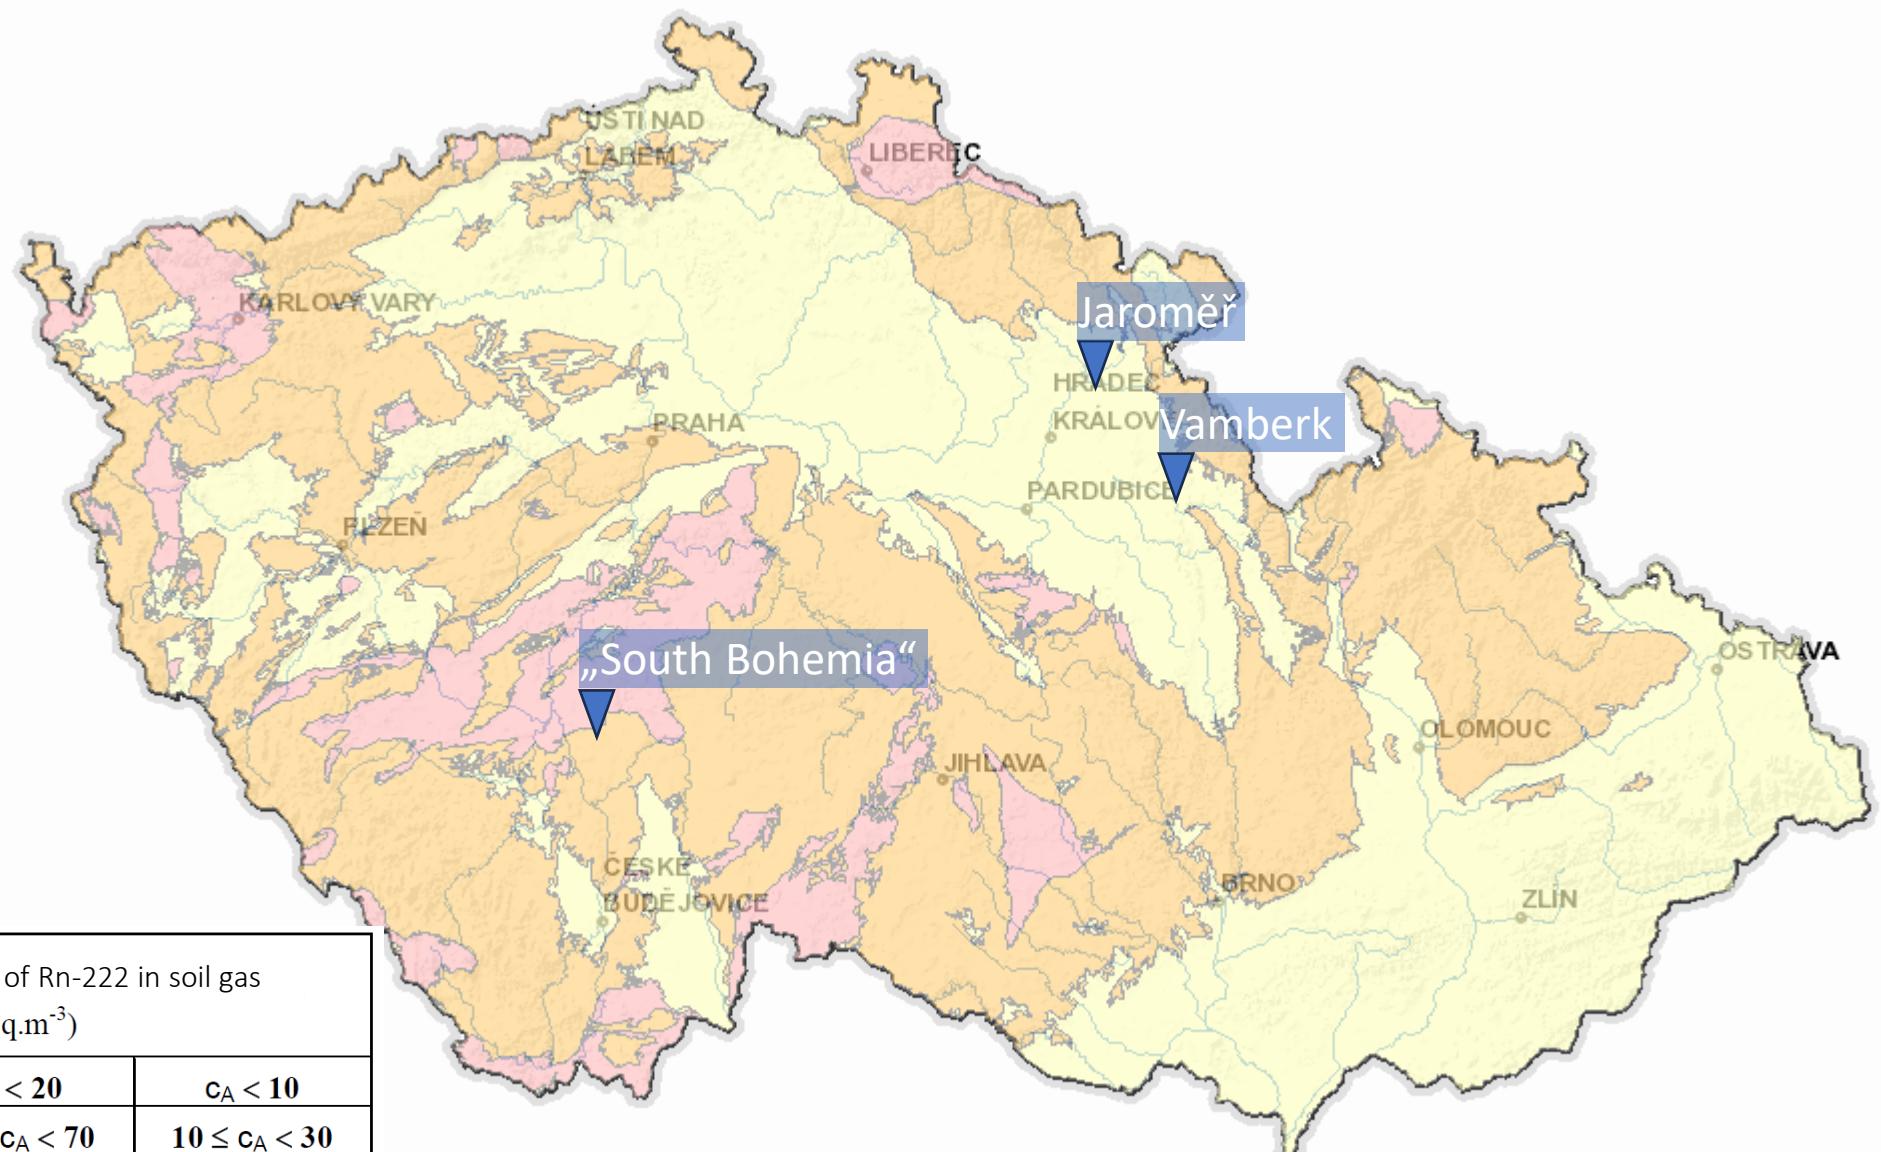
Radon index	Volumetric activities of Rn-222 in soil gas (kBq.m <sup>-3</sup> )		
Low	$c_A < 30$	$c_A < 20$	$c_A < 10$
Medium	$30 \leq c_A < 100$	$20 \leq c_A < 70$	$10 \leq c_A < 30$
High	$c_A \geq 100$	$c_A \geq 70$	$c_A \geq 30$
	Low $K < 4 \cdot 10^{-13} \text{ m}^2$	Medium $K > 4 \cdot 10^{-13} \text{ m}^2$	High

Gas permeability of soils

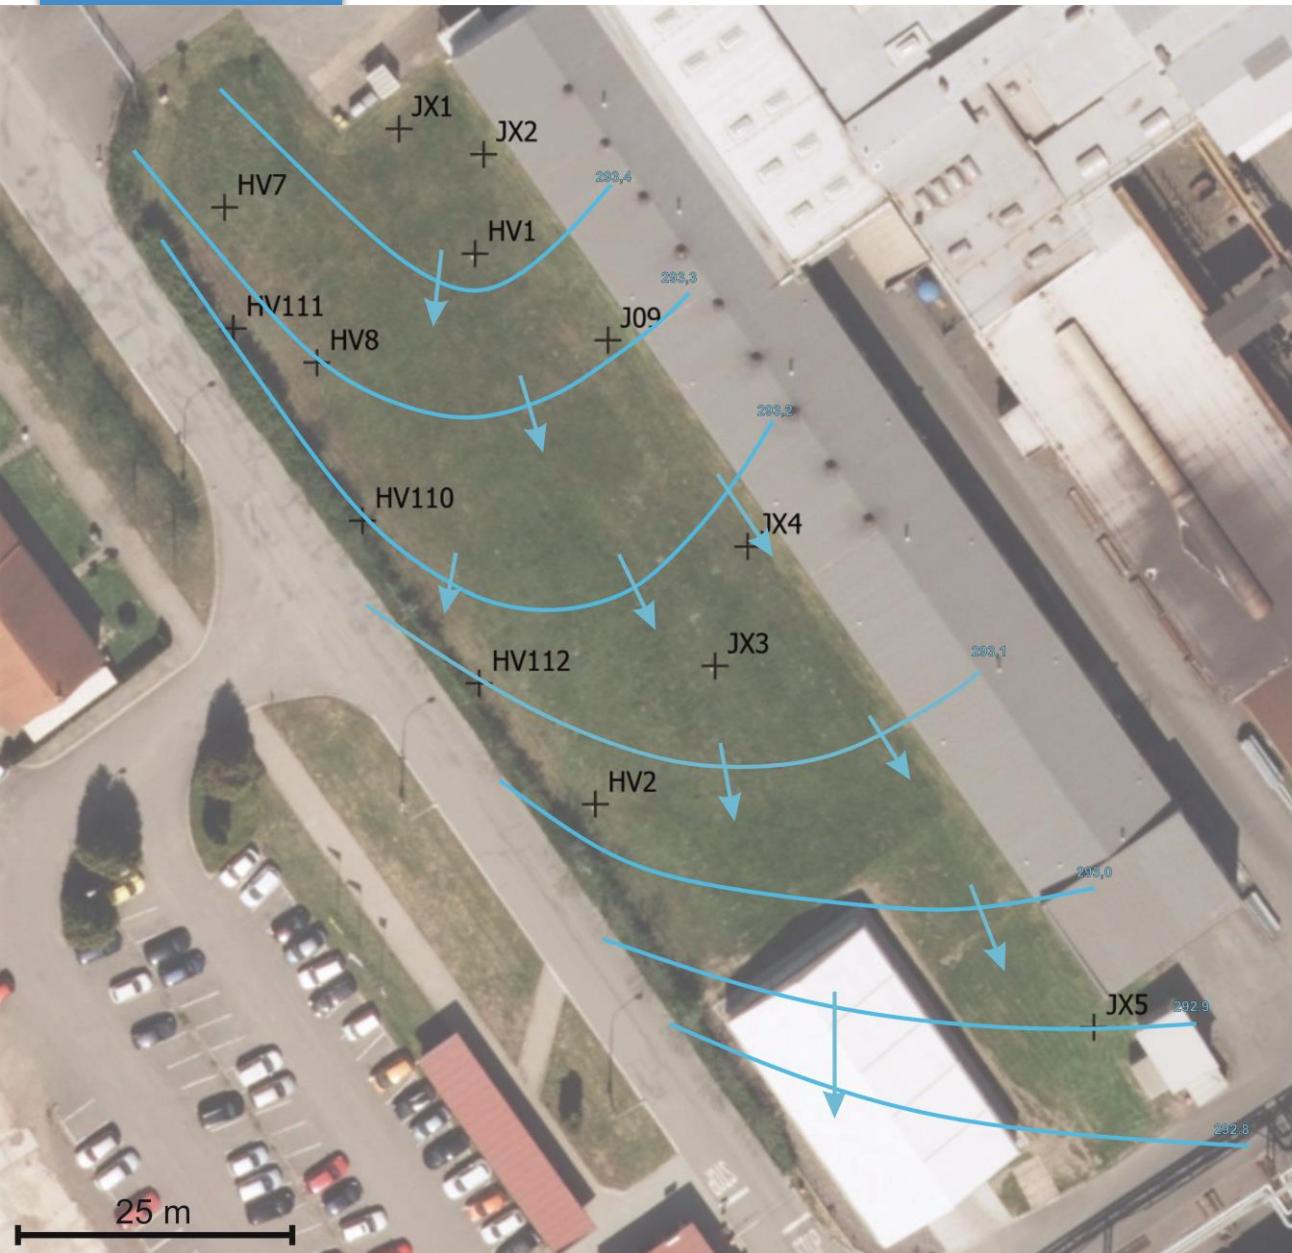
*Bedrock: marlite*

*Hydrogeology:*

- Groundwater depth: 2 – 3 m b.t.
- Shallow quaternary aquifer:  $K = 1 - 9 \cdot 10^{-5}$  m/s

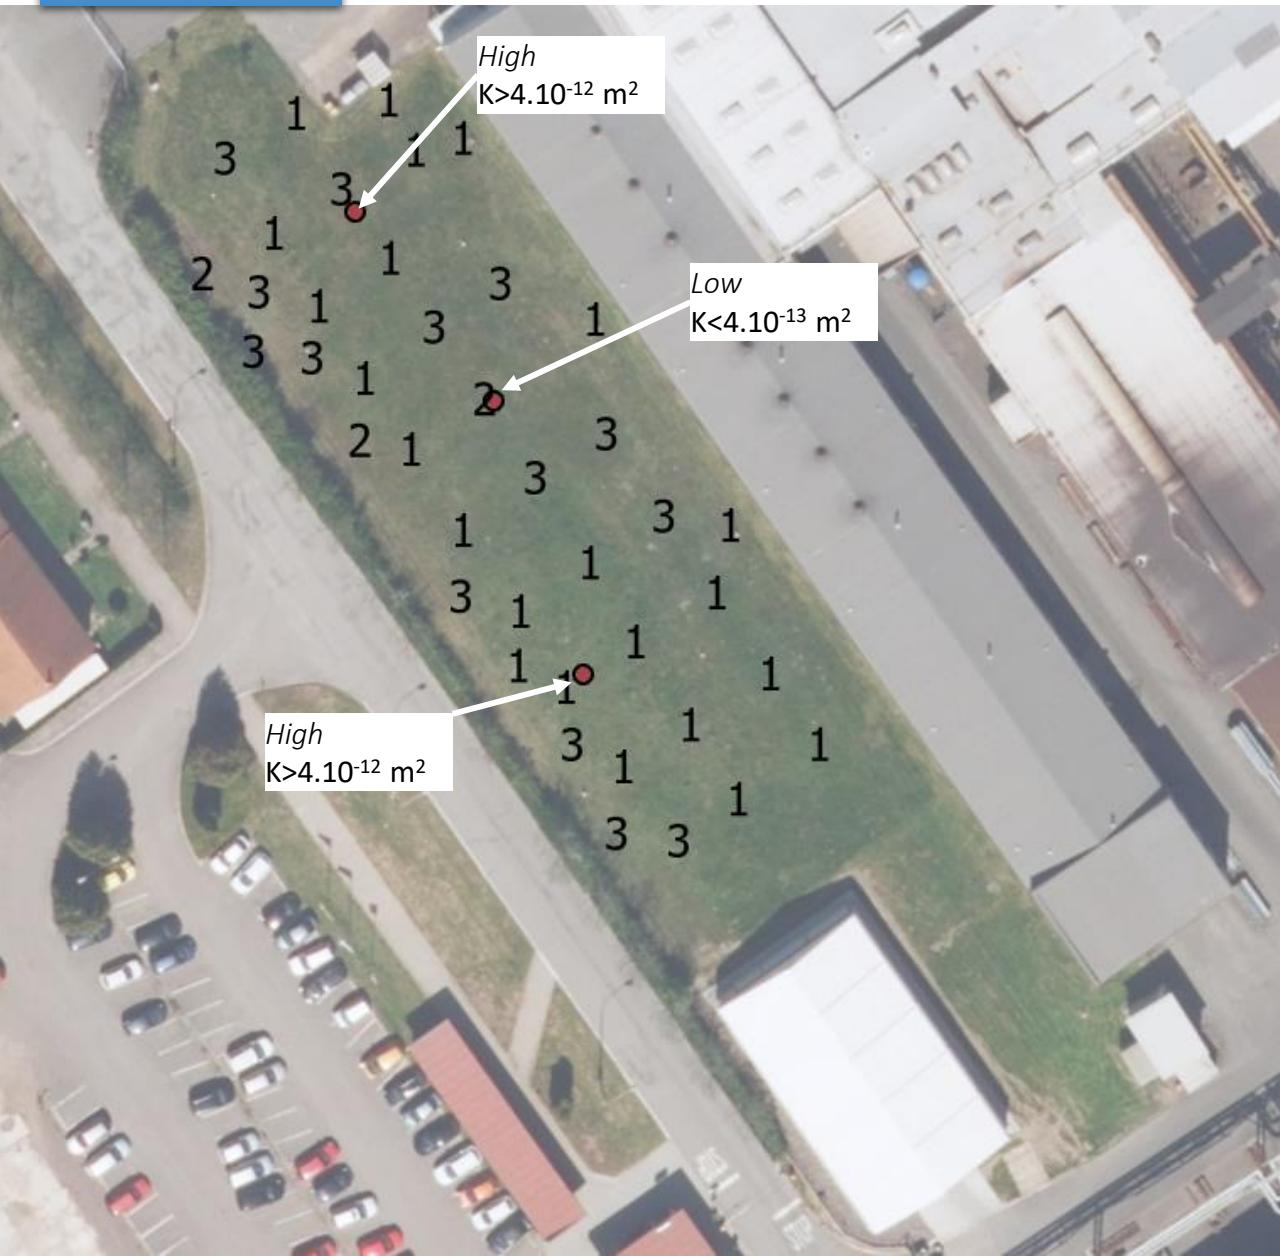
## Soil profile characterisation:

- Layer of soil of anthropogenic origin 0,5 – 2,9
- Sandy loam to loam, clay in spots, construction waste
- below anthropogenic layer: holocene fluvial deposits of clay and loam character
- Lowest part of quaternary: fluvial gravels

## Dominant soil gas permeability:

- Subjectively during sampling (80 cm): High

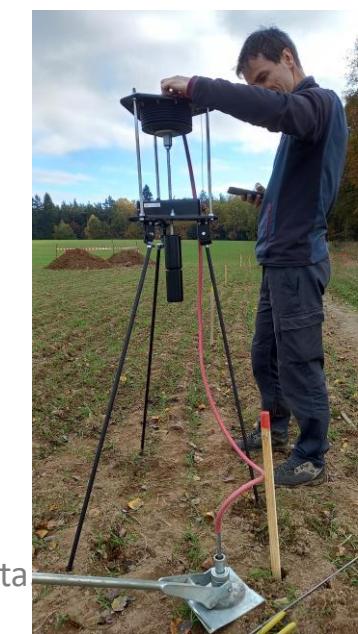
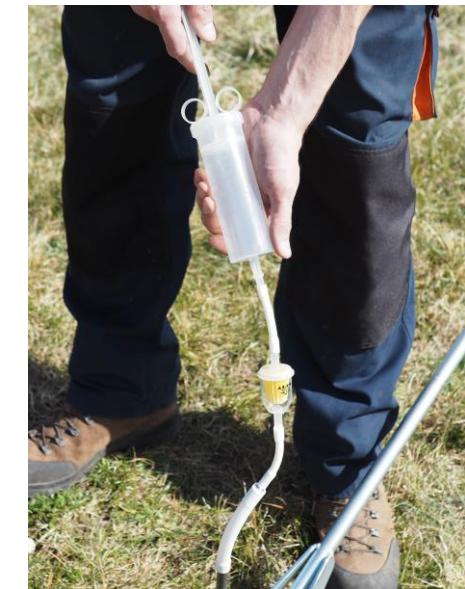
3=Low  
 $K<4.10^{-13} \text{ m}^2$

2=Medium

1=High  
 $K>4.10^{-12} \text{ m}^2$

- Measured K by JOK apparatus: 3 points

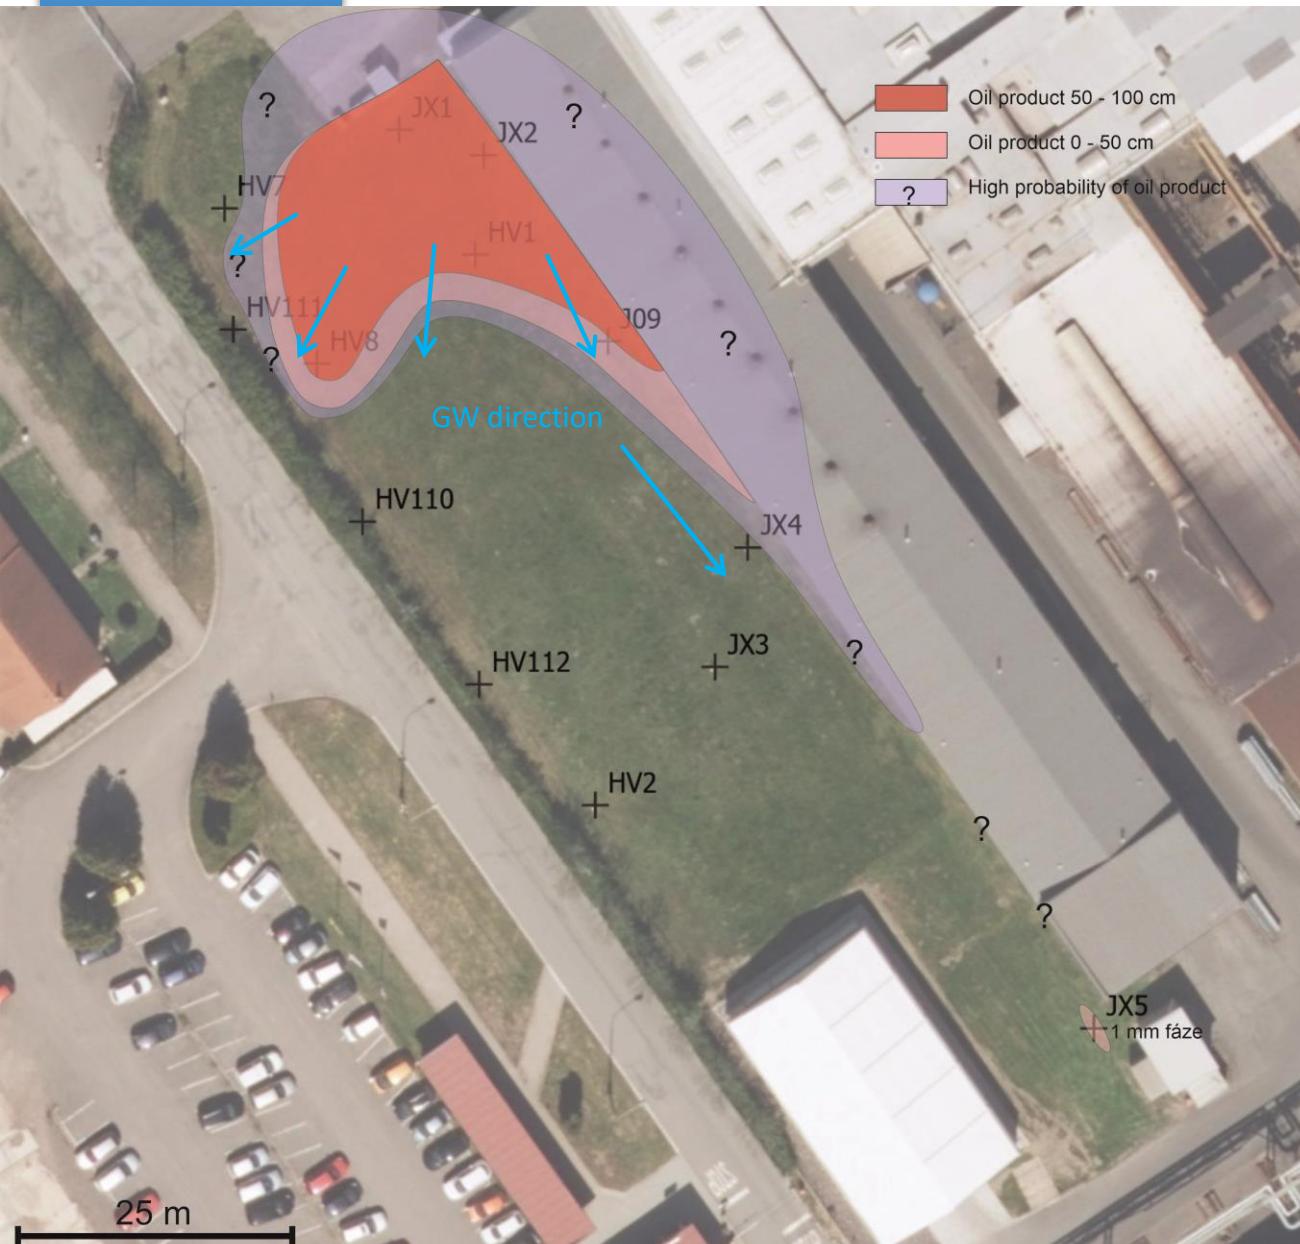
### Contamination data:

- Source of contamination: Cutting oil warehouse (removed in 1987)
- Type of contamination:  
n-alkanes in the range C16-C35 with a maximum of C21-C30, corresponding to mineral oils, low solubility in water (C10-C40 0,1 – 0,5 mg/l)  
+ light contamination of chlorinated ethenes in GW (TCE: 0,5 ug/l, PCE 4,2 ug/l)
- Max contamination in soil:  
**C10-C40 52,5 g/kg, avg 10 g/kg in the plume area**  
**benzo(a)pyrene: 0,306 mg/kg**
- measured phase thickness at the groundwater level:  
**1 m at maximum**
- Estimated contaminated area: **850 m<sup>2</sup>**
- Estimated volume of oil product: **45 tonnes**
- Estimated volume of contaminated soil: **2500 m<sup>3</sup>**
- Extent and spread of contamination: in the direction of GW + preferred pathway along the building
- **Estimated velocity of oil product spread: cm/year**

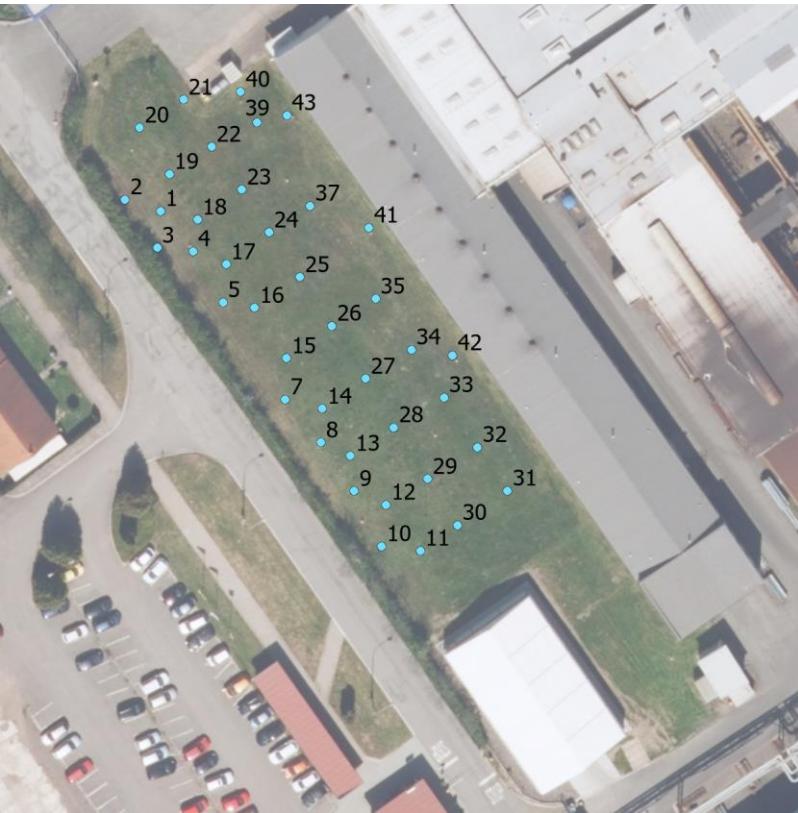
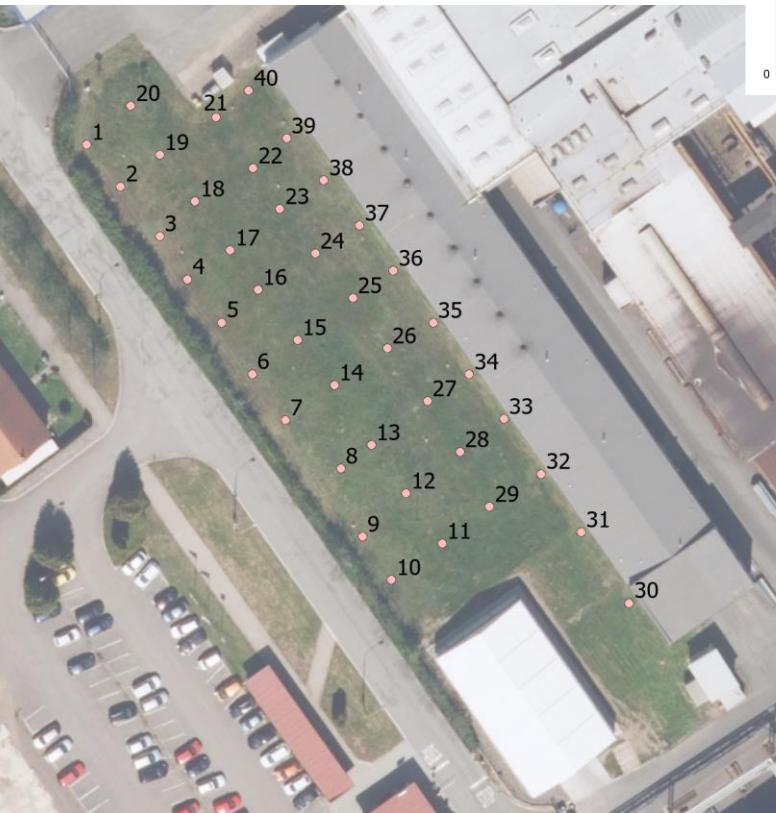
### *Methodology of Radon measuring:*

- 2 campaigns: 03/2025 and 05/2025
- Soil gas sampling in 80 cm and 50 cm depth
- Volumetric activity of Rn-222 (Bq/m<sup>3</sup>)
- RM-2 device with ionization chamber
- 40 sampling points, 10 x 10 m grid
- Outdoor temperature: 8°C and 15°C

**40 sampling points**

**Average activity**  
 $37,9 \times 20,9$  kBq/m<sup>3</sup>

**Coef. of variation**  
 $76\% \times 53\%$

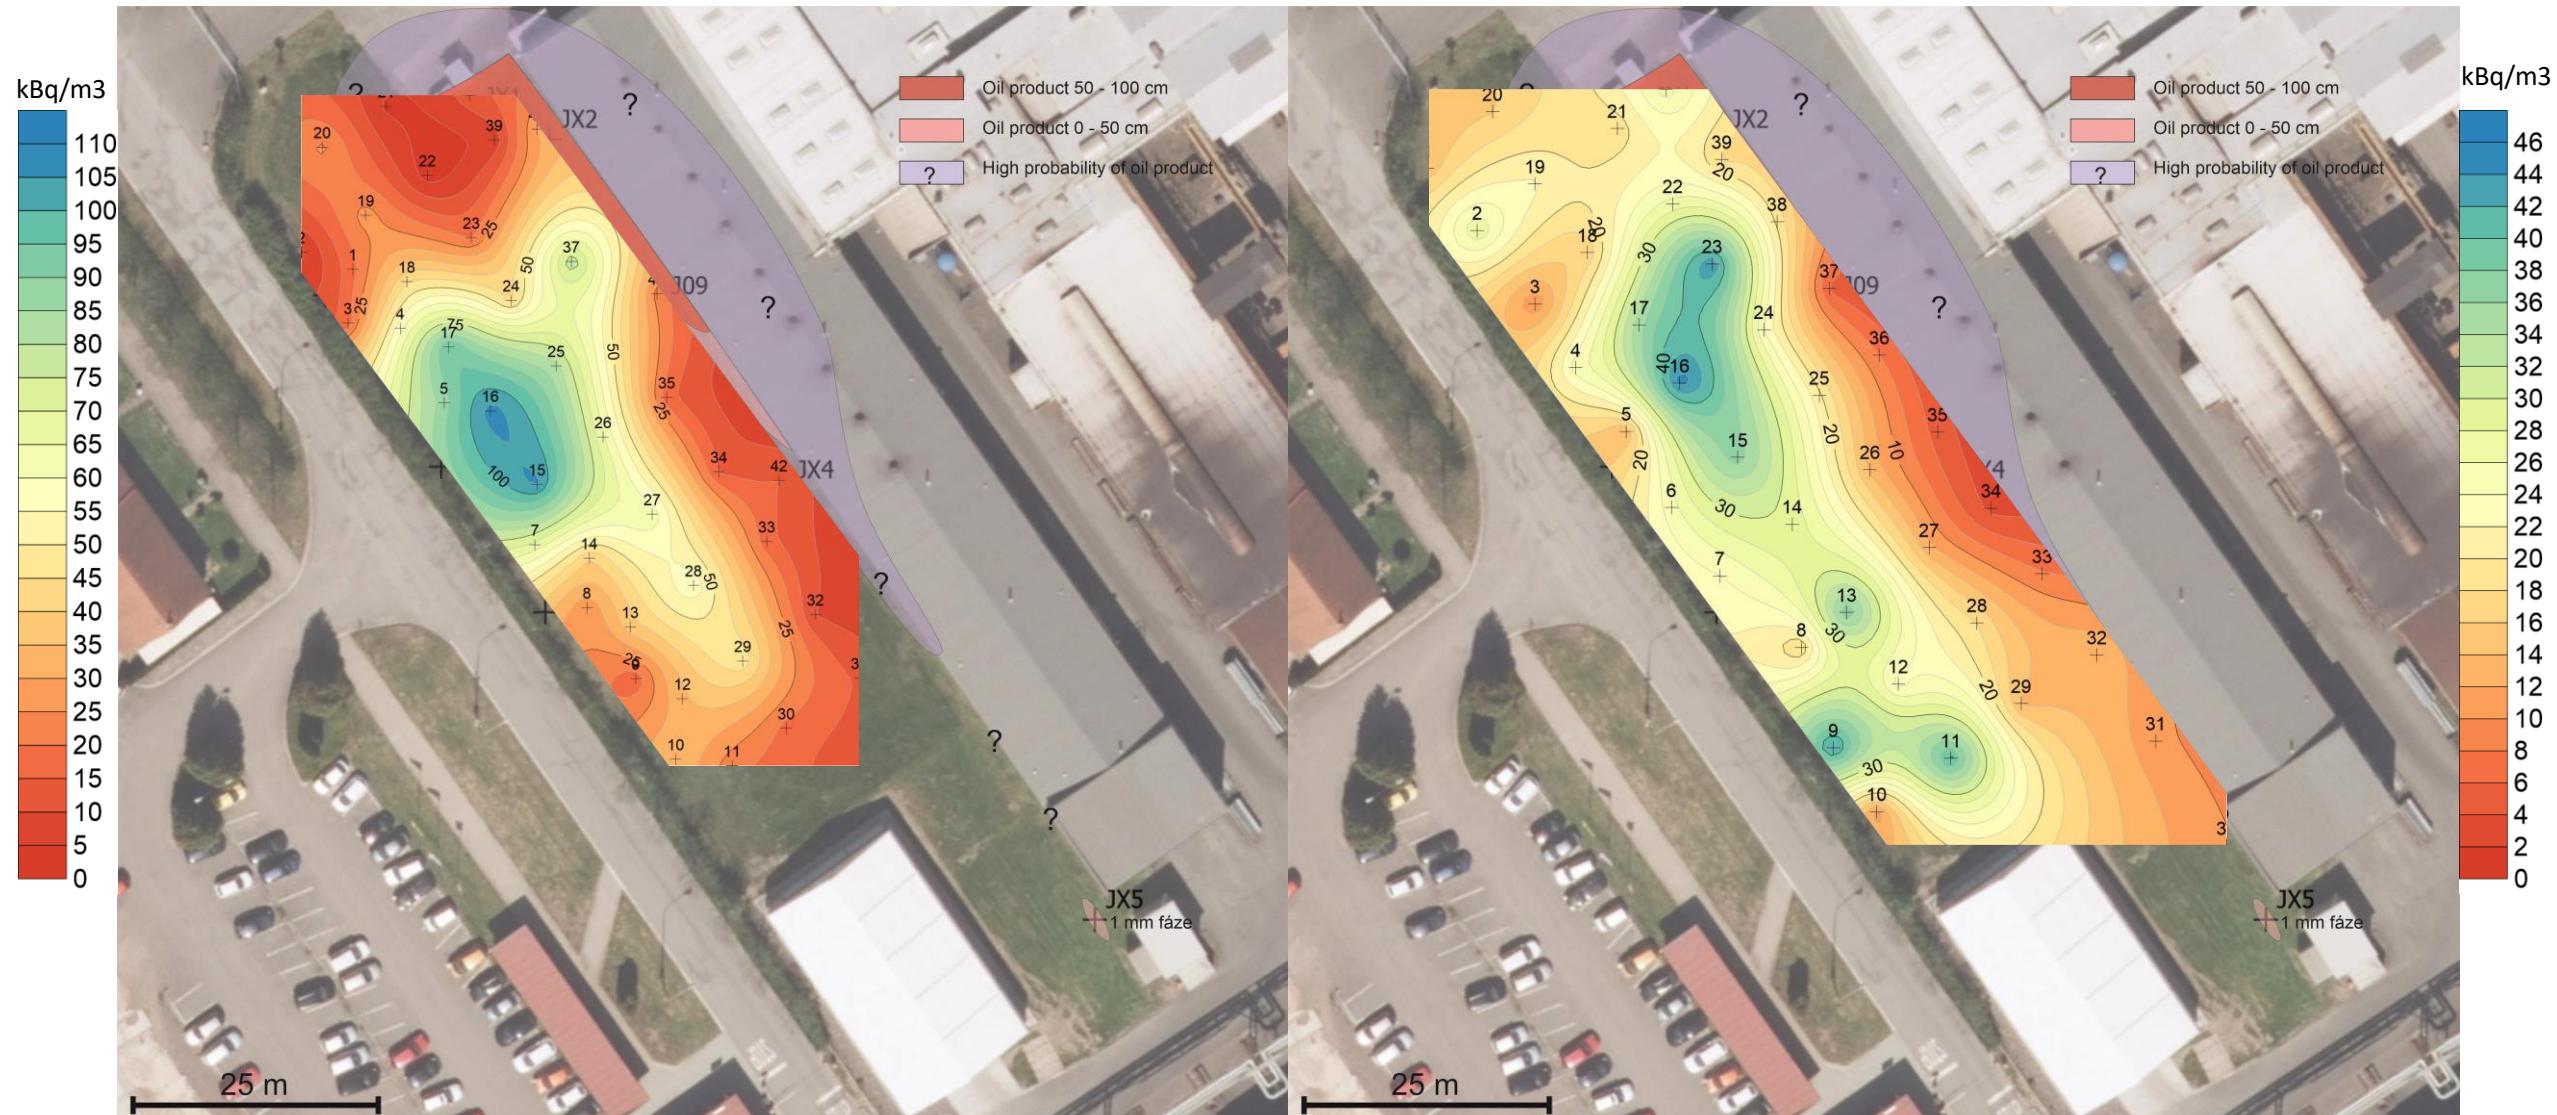
## Radon measuring - Results

03/2025 and 05/2025

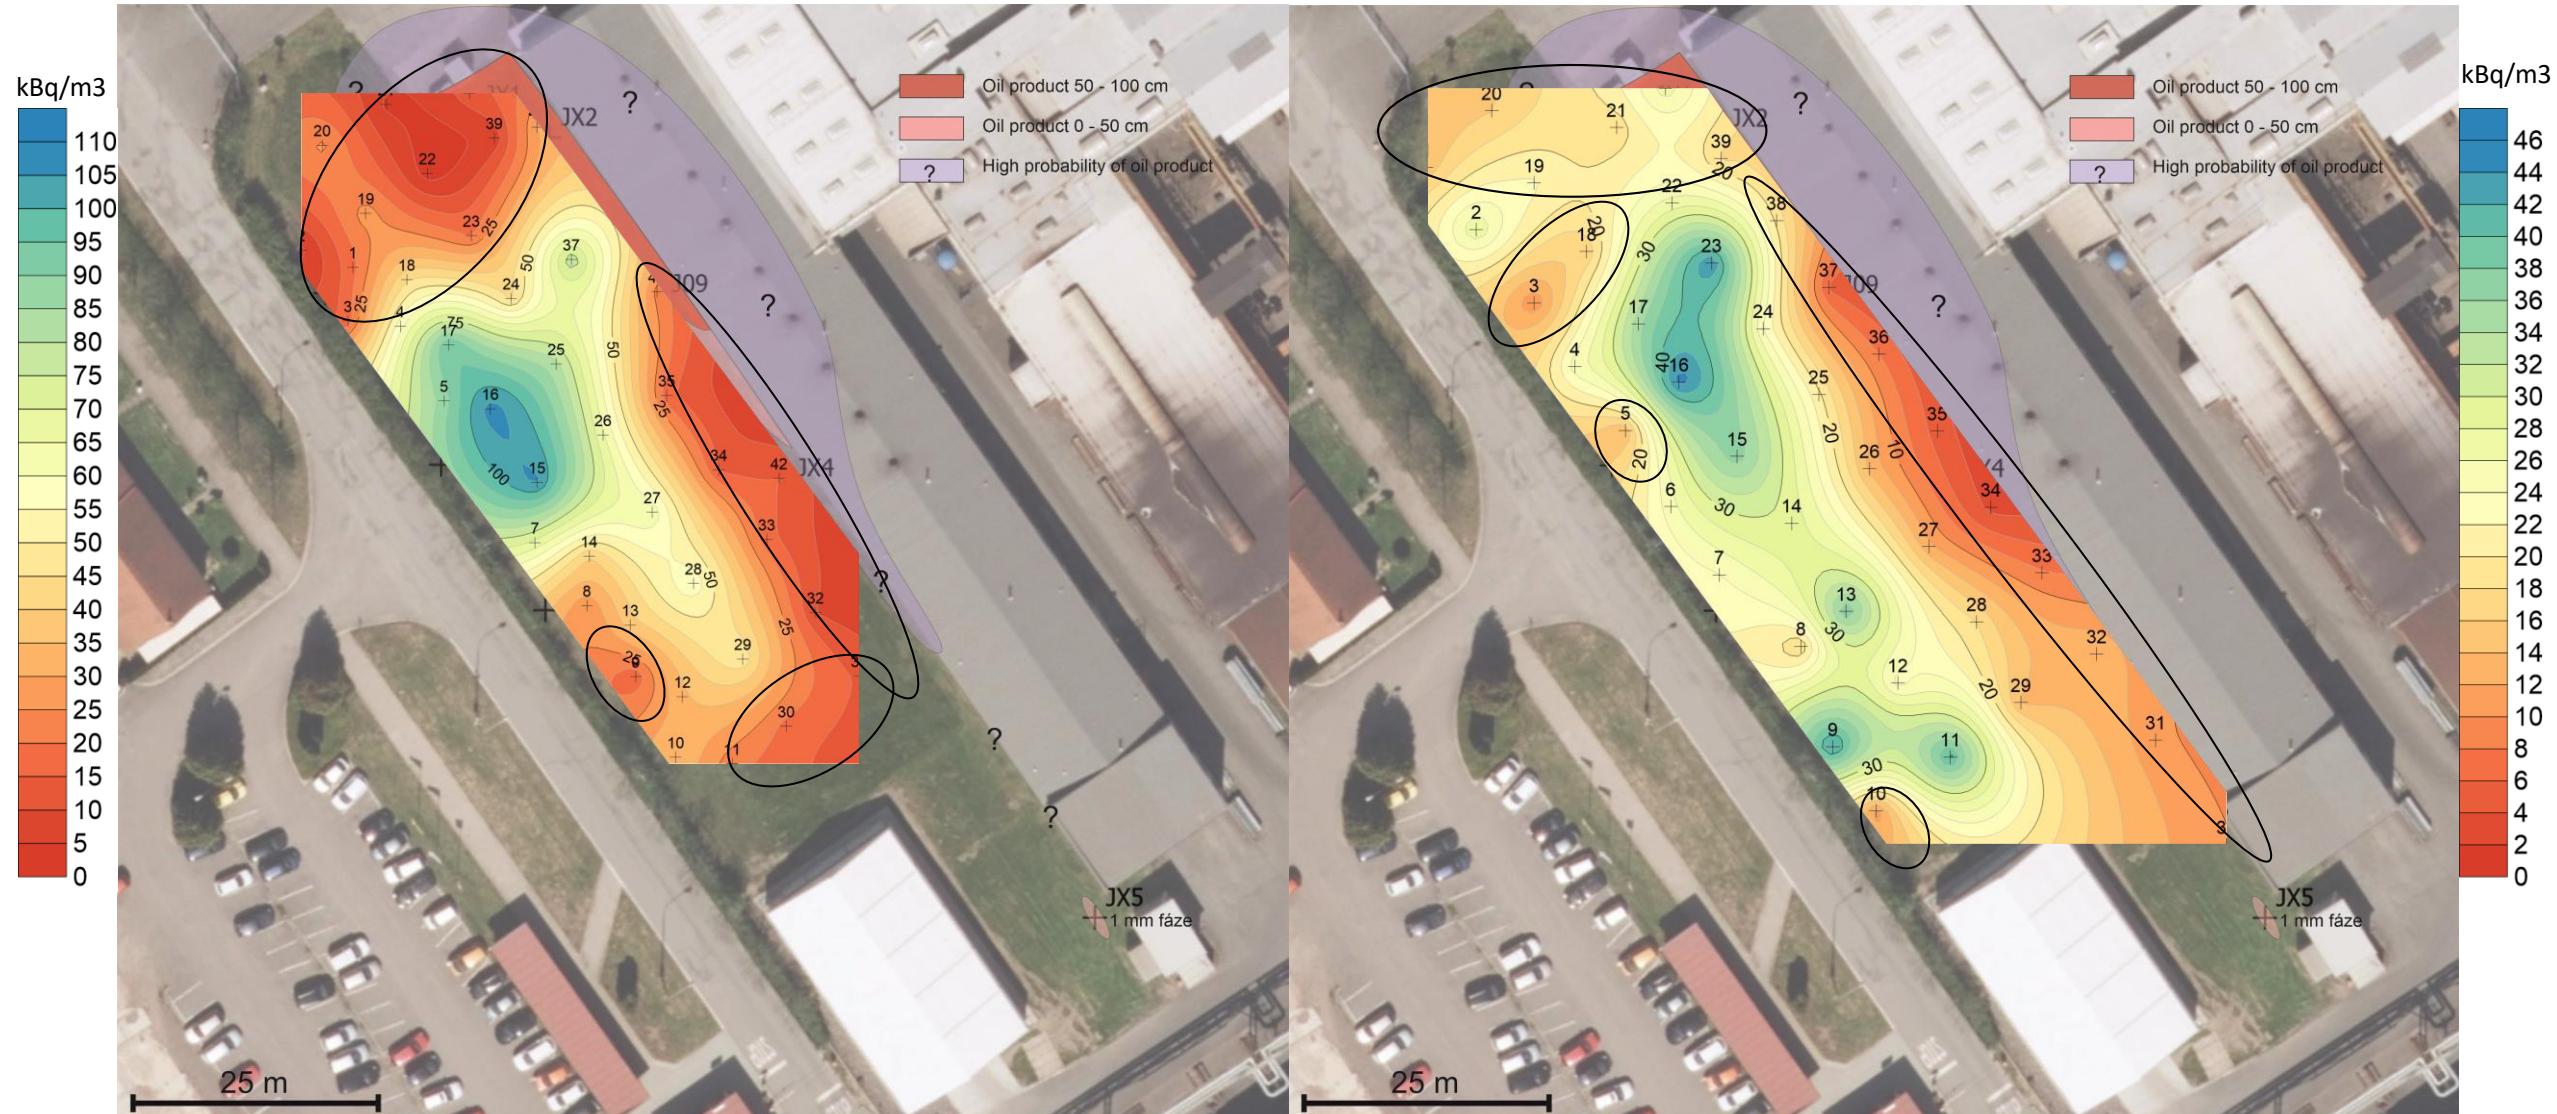
## Radon measuring - Results

03/2025 and 05/2025

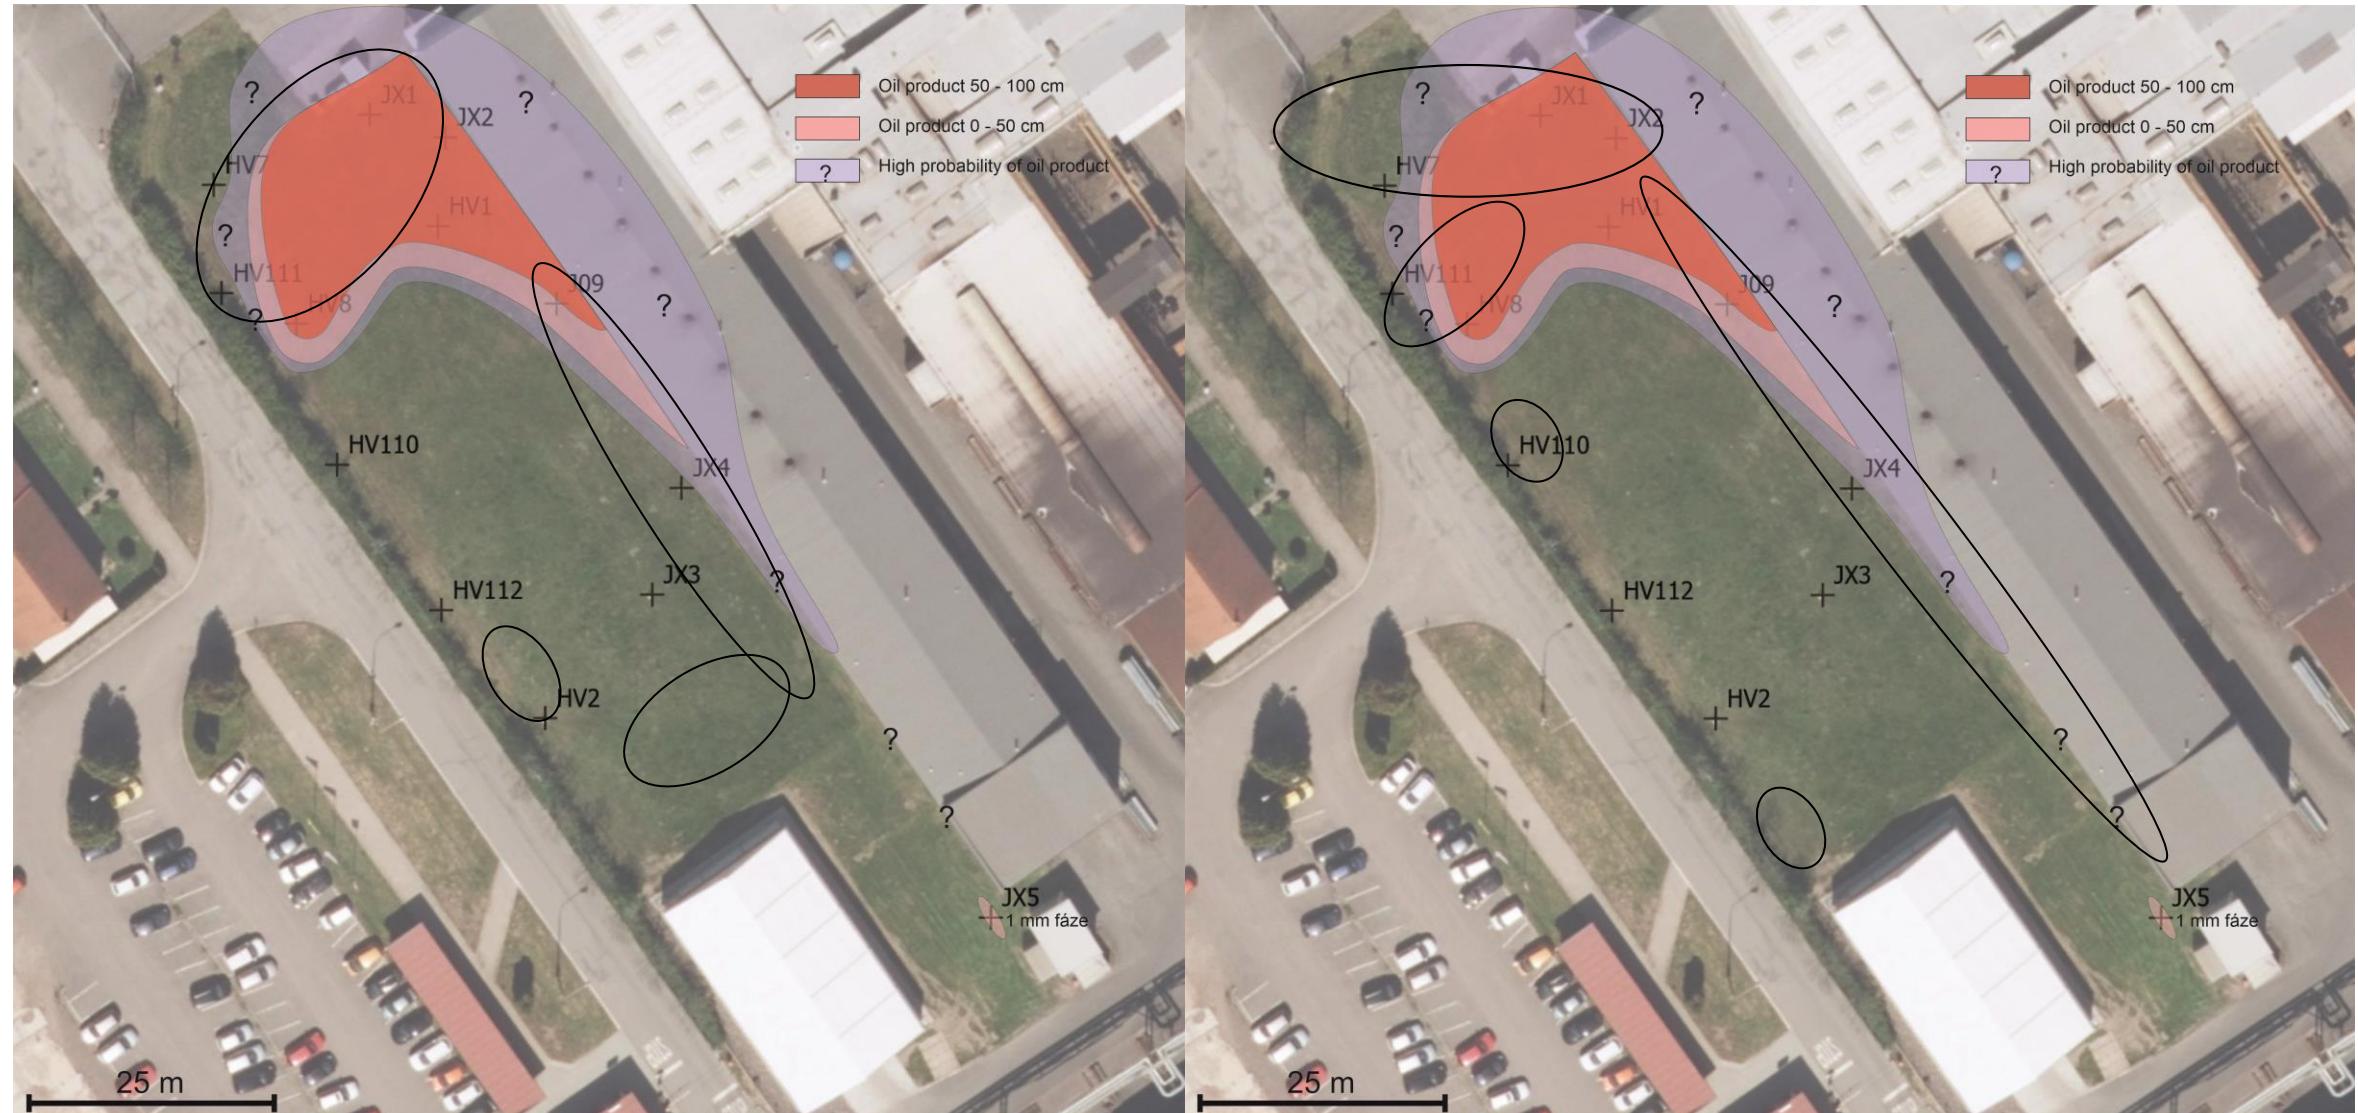
## Radon measuring - Results

03/2025 and 05/2025

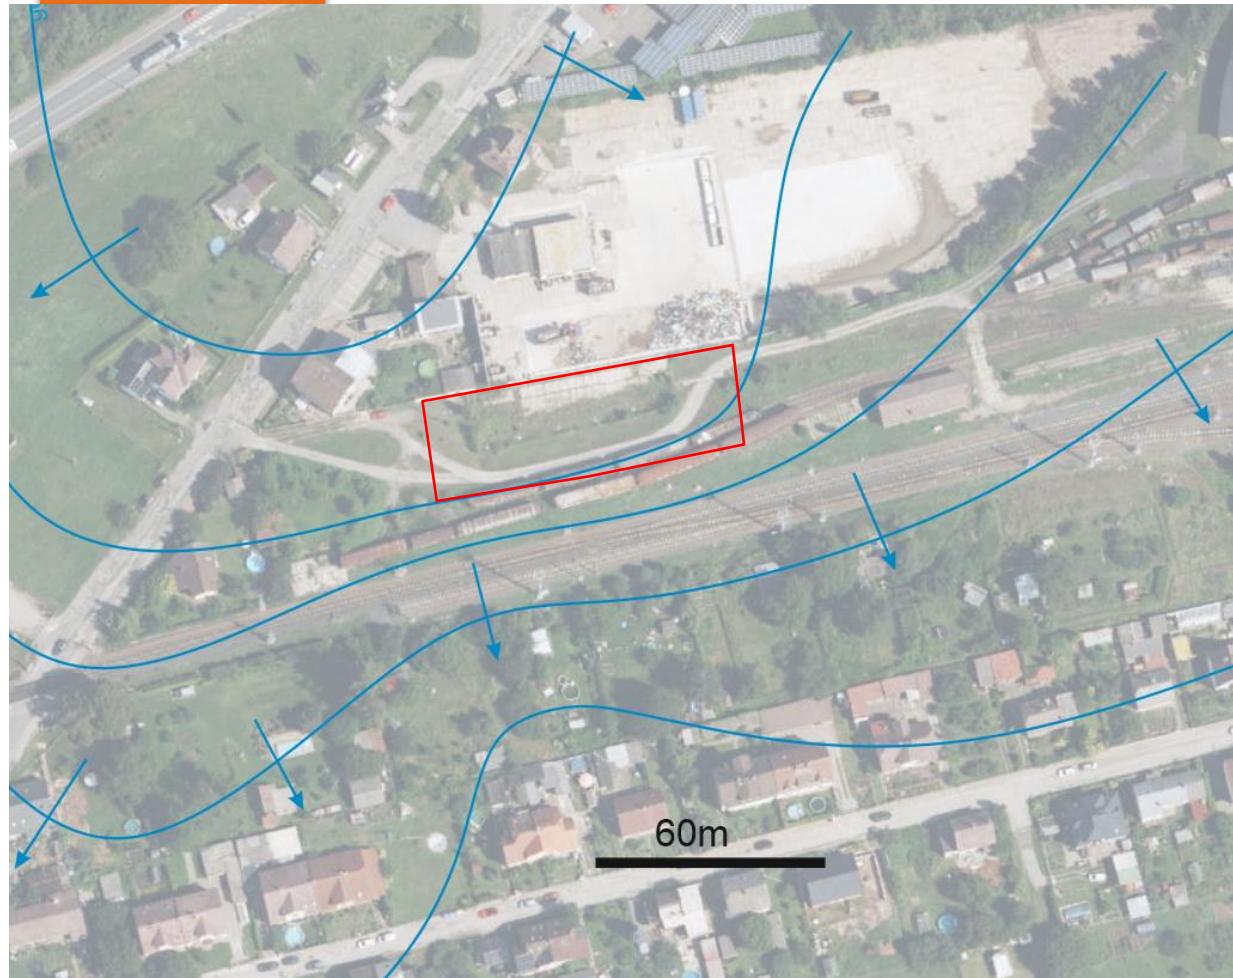
*Bedrock: calcareous siltstone*

### *Hydrogeology:*

- Shallow aquifer: gravel-sand sediments of the Elbe terraces + weathered zone of the underlying Cretaceous siltstone
- Significant oscillation of GW during the year 2 – 6 m b.t.
- $K = 3.10^{-7} - 3.10^{-3}$  m/s

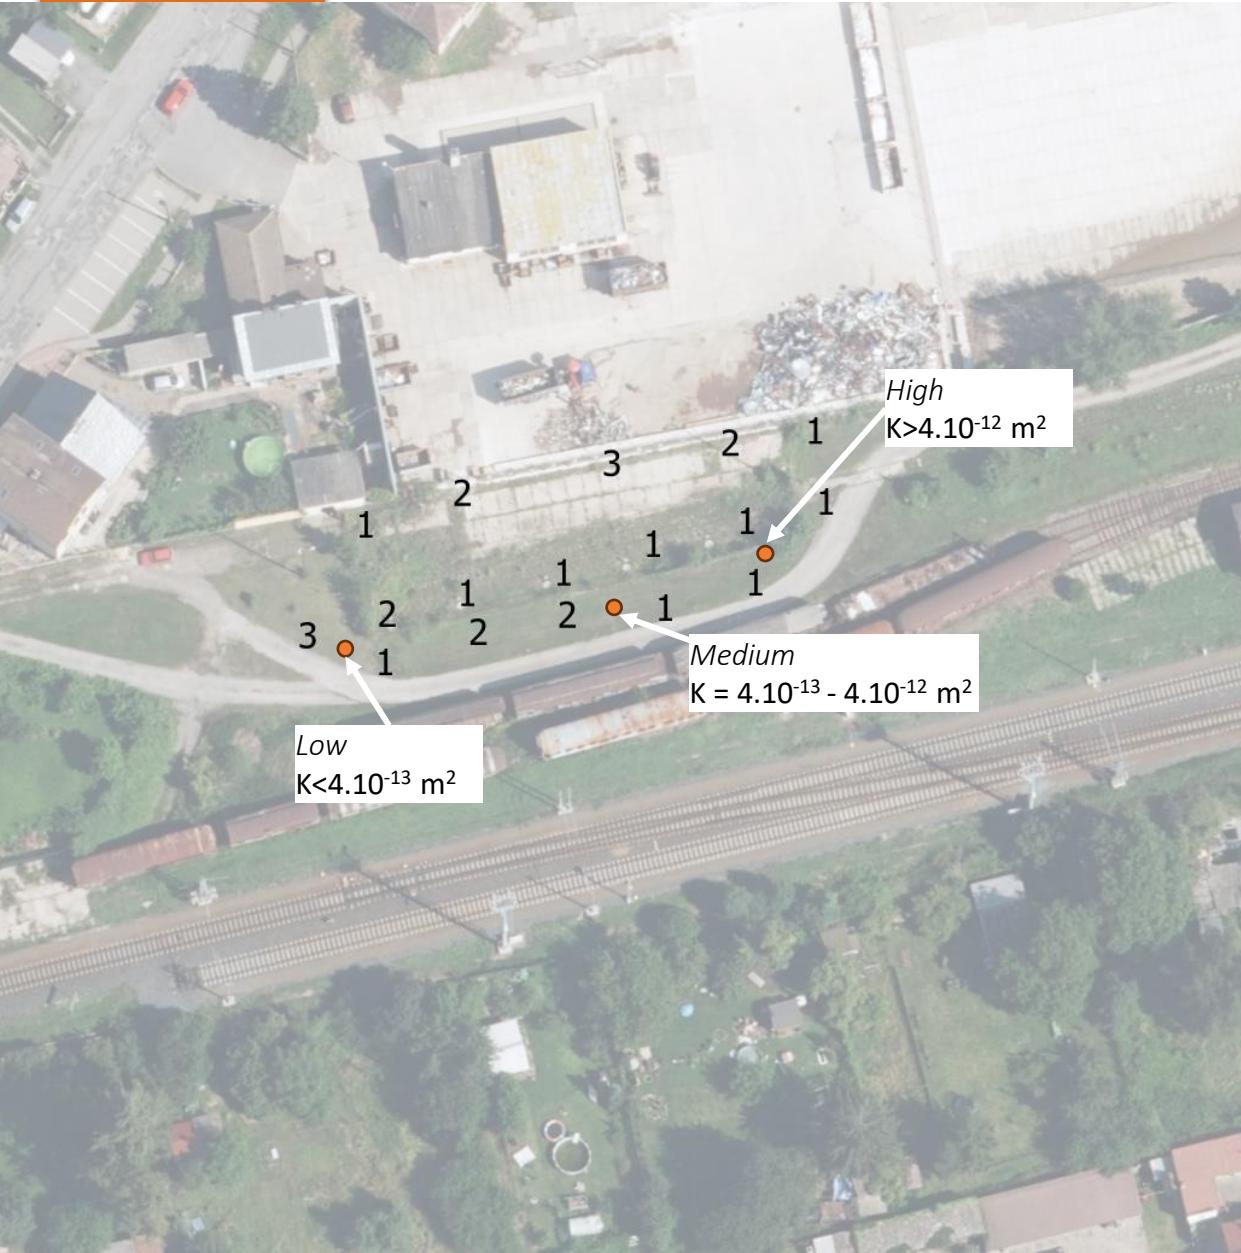
## Soil profile characterisation:

- Layer of soil of anthropogenic origin 0 – 0,7 m b.t.
- Gravel mixed with clay and sand
- Below anthropogenic layer: clay soil

## Dominant soil gas permeability:

- Subjectively during sampling (80 cm): High

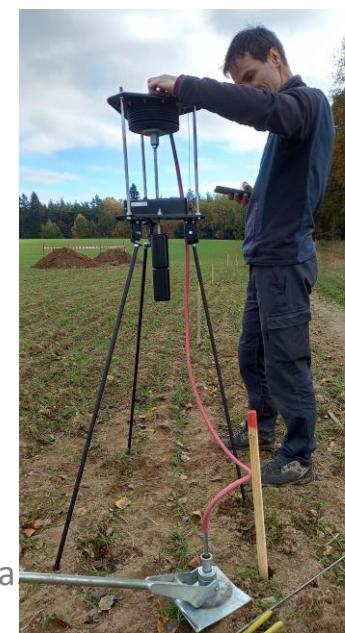
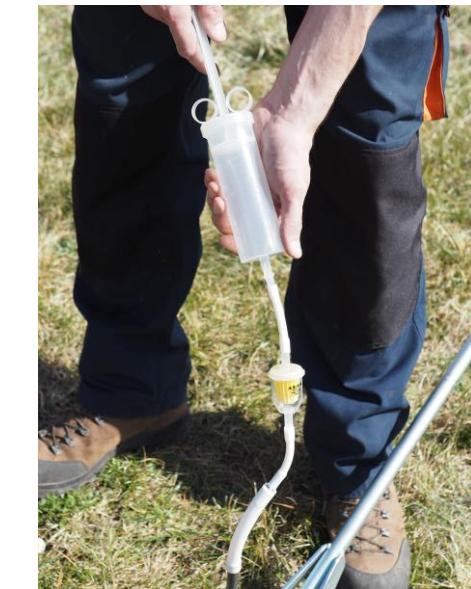
3=Low  
 $K < 4.10^{-13} \text{ m}^2$

2=Medium

1=High  
 $K > 4.10^{-12} \text{ m}^2$

- Measured K by JOK apparatus: 3 points

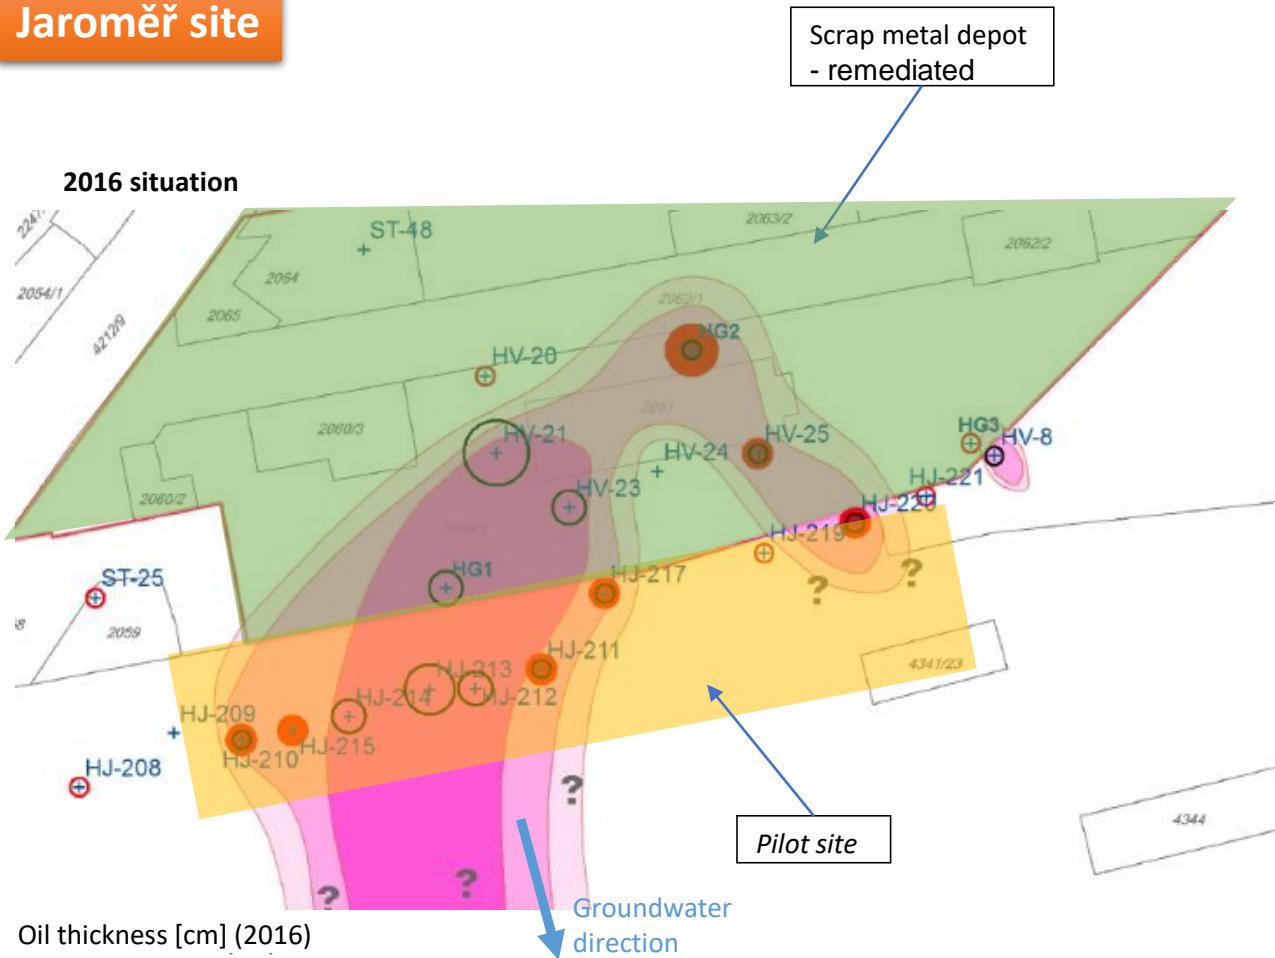
2025:  
Oil thickness max: 2 mm  
C10-40 max: 386 mg/l

### Contamination data:

- Source of contamination: underground storage tanks (removed and site remediated 2022-2023)
- Type of contamination: n-alkanes in the range C12-C25 corresponding to the mixture of benzine and light heating oil (C10-C40 max. 386 mg/l in 2024)
- Max contamination in soil: C10-C40 1000 – 3000 mg/kg
- measured phase thickness at the groundwater level: **2 mm at maximum (2025)**
- Estimated contaminated area: **500-700 m<sup>2</sup>**
- Estimated volume of oil product: **Not known**
- Estimated volume of contaminated soil: **Not known**
- Extent and spread of contamination: Oil product fixed to less permeable soil pockets and perched aquifers, gradually washed away by high oscillating groundwater in the direction of flow
