# Case studies (RADOIL project pilot sites)

Measurement of radon in soil gas as an indicator of contamination by petroleum substances

RADOIL - Measurement of radon in soil gas as an indicator of contamination by petroleum substances

**Methodology for indirect  
measurement of oil contamination  
using the natural tracer Rn**

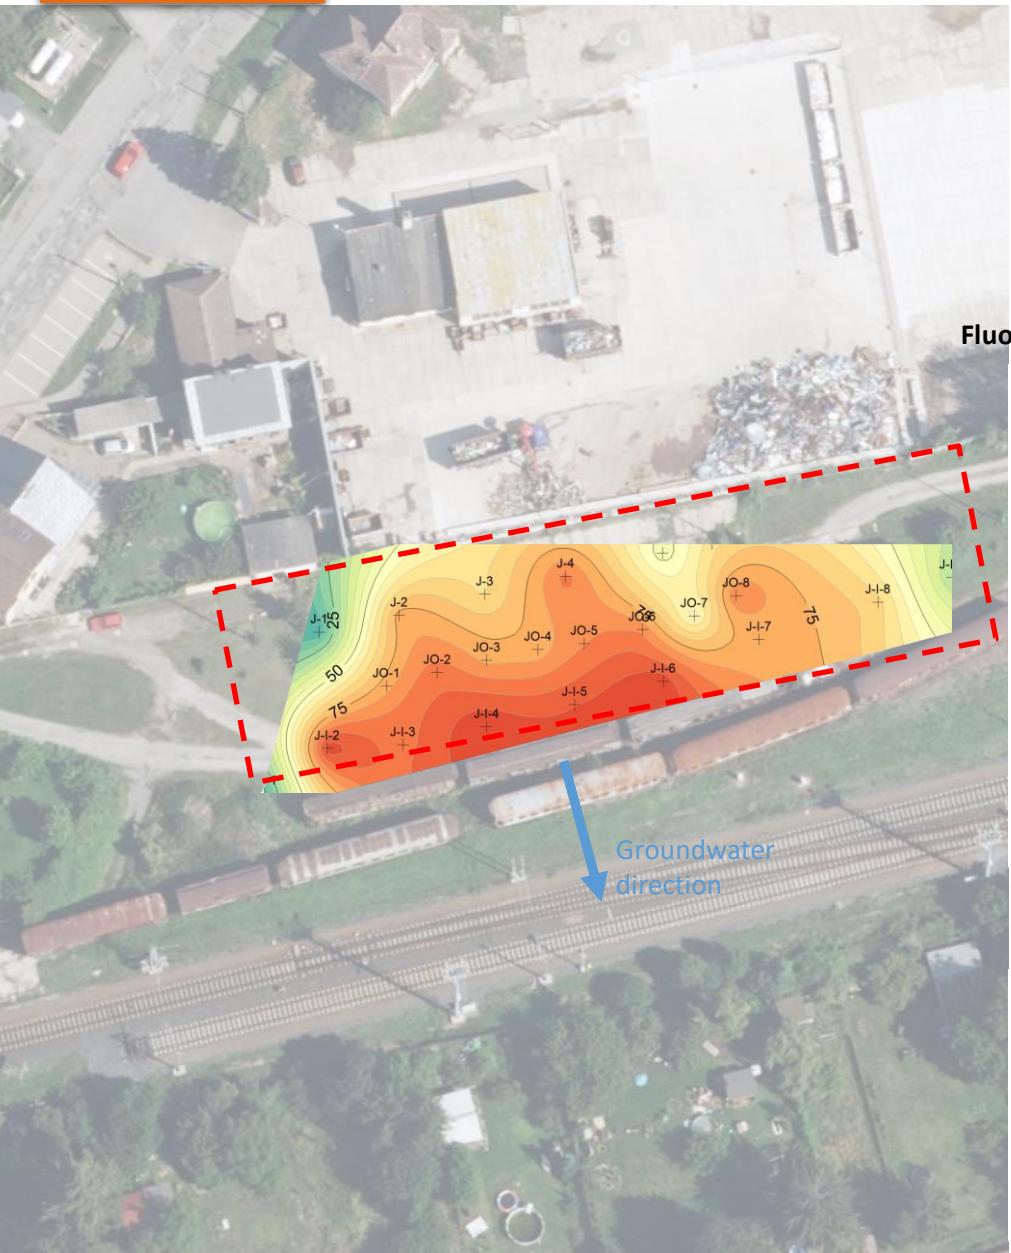
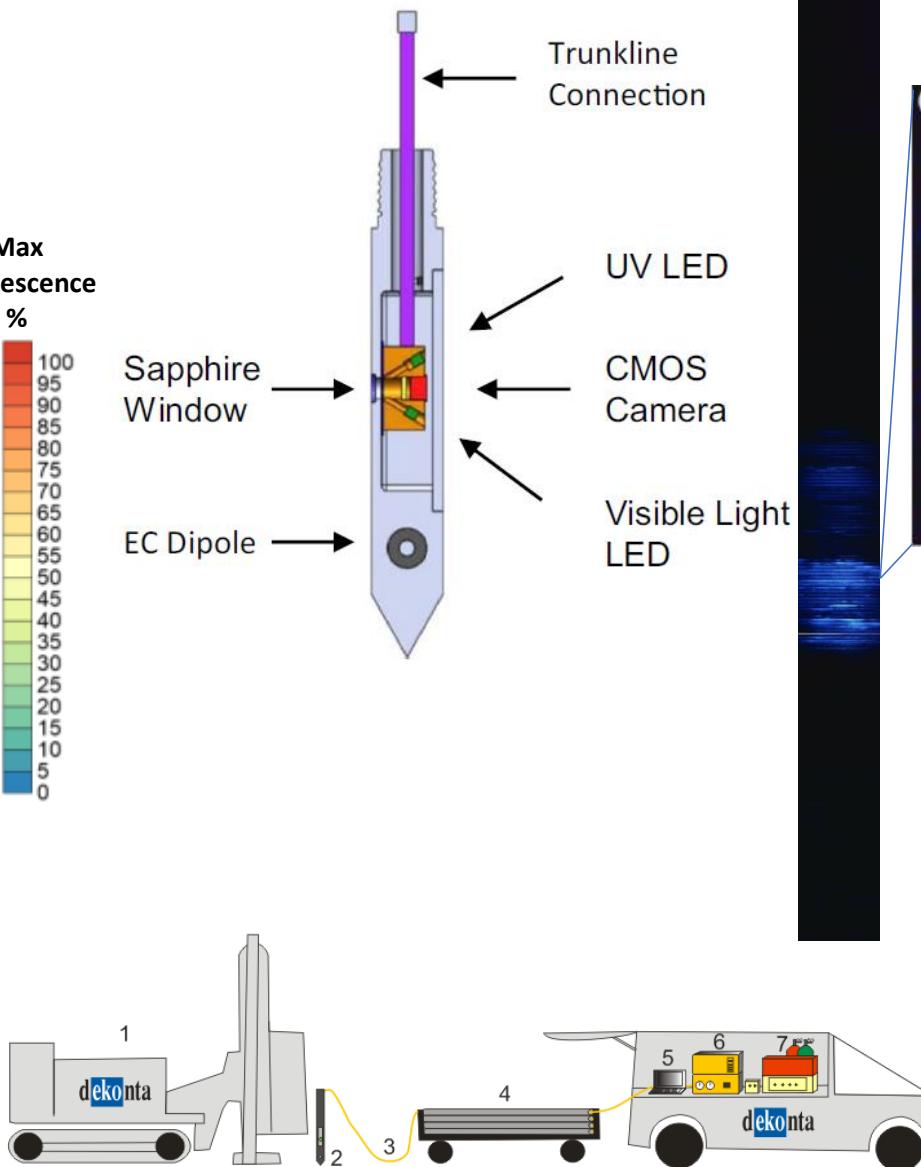
### Contamination data:

- Contamination survey using OIP (Optical Image Profiler)

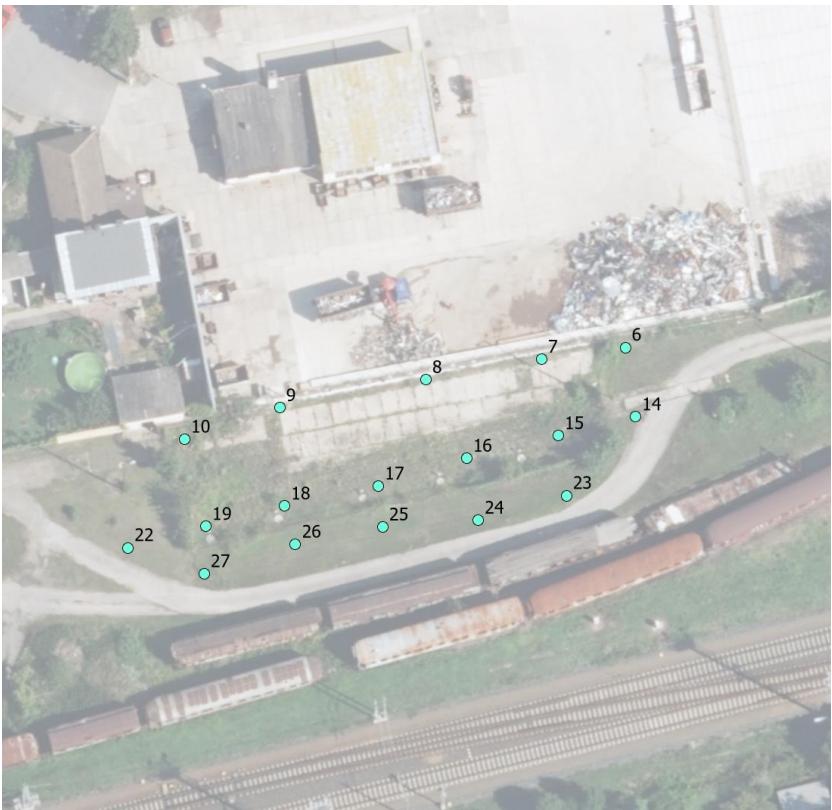
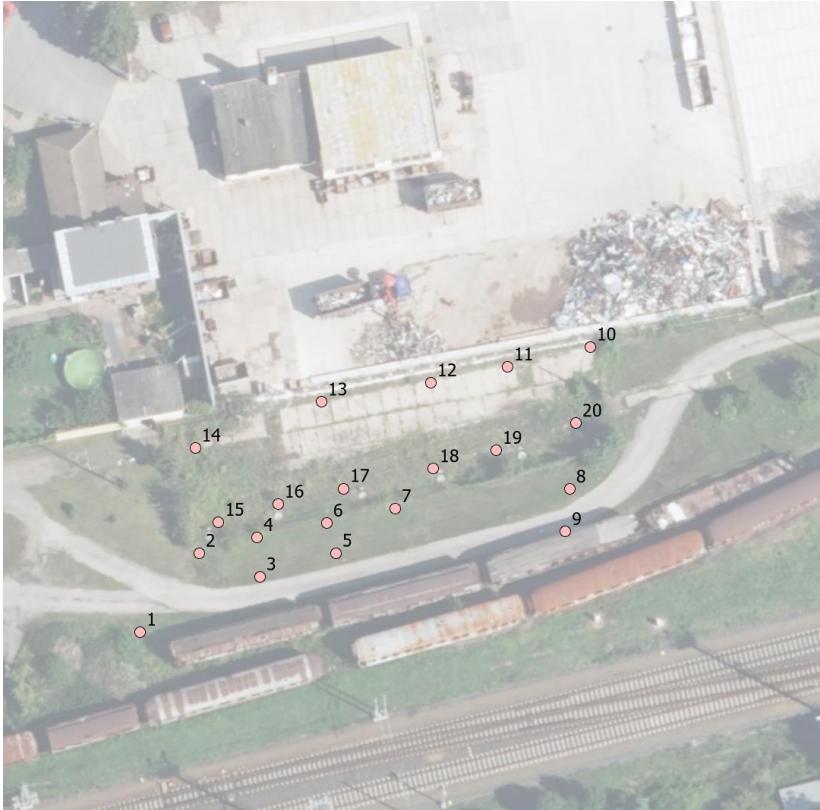
**Jaroměř site****17/20 sampling points***Methodology of Radon measuring:*

- 2 campaigns: 12/2024 and 06/2025
- Soil gas sampling in 80 cm and 50 cm depth
- Volumetric activity of Rn-222 (Bq/m<sup>3</sup>)
- RM-2 device with ionization chamber
- 17 and 20 sampling points, 10 x 10 m grid
- Outdoor temperature: 3°C and 28°C

**Average activity** $35,4 \times 22,2$  kBq/m<sup>3</sup>**Coef. of variation**

72% x 78%

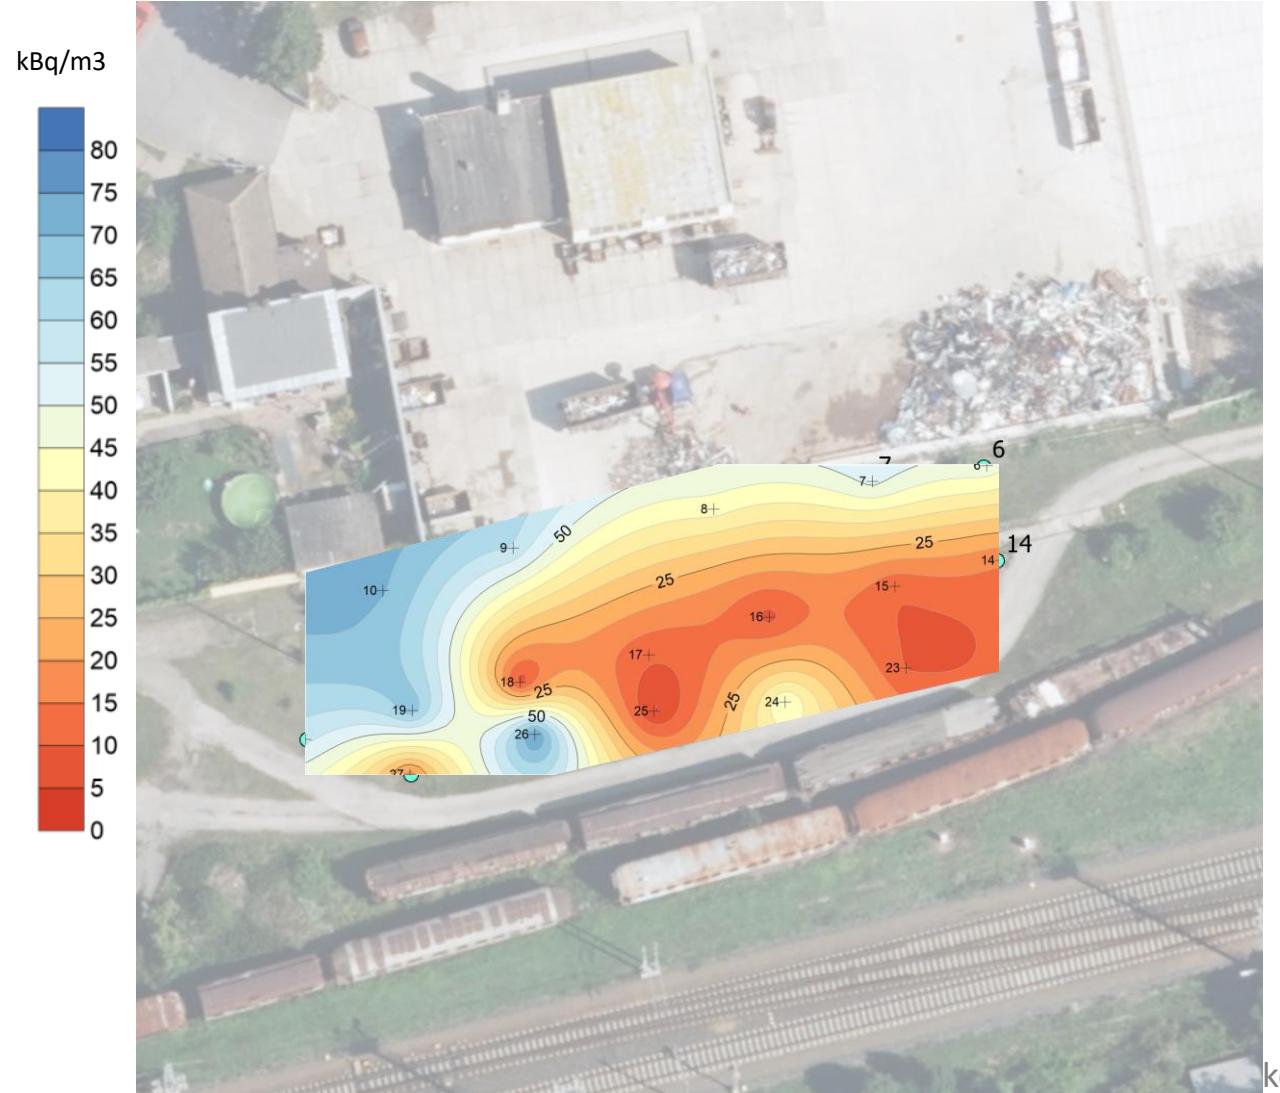
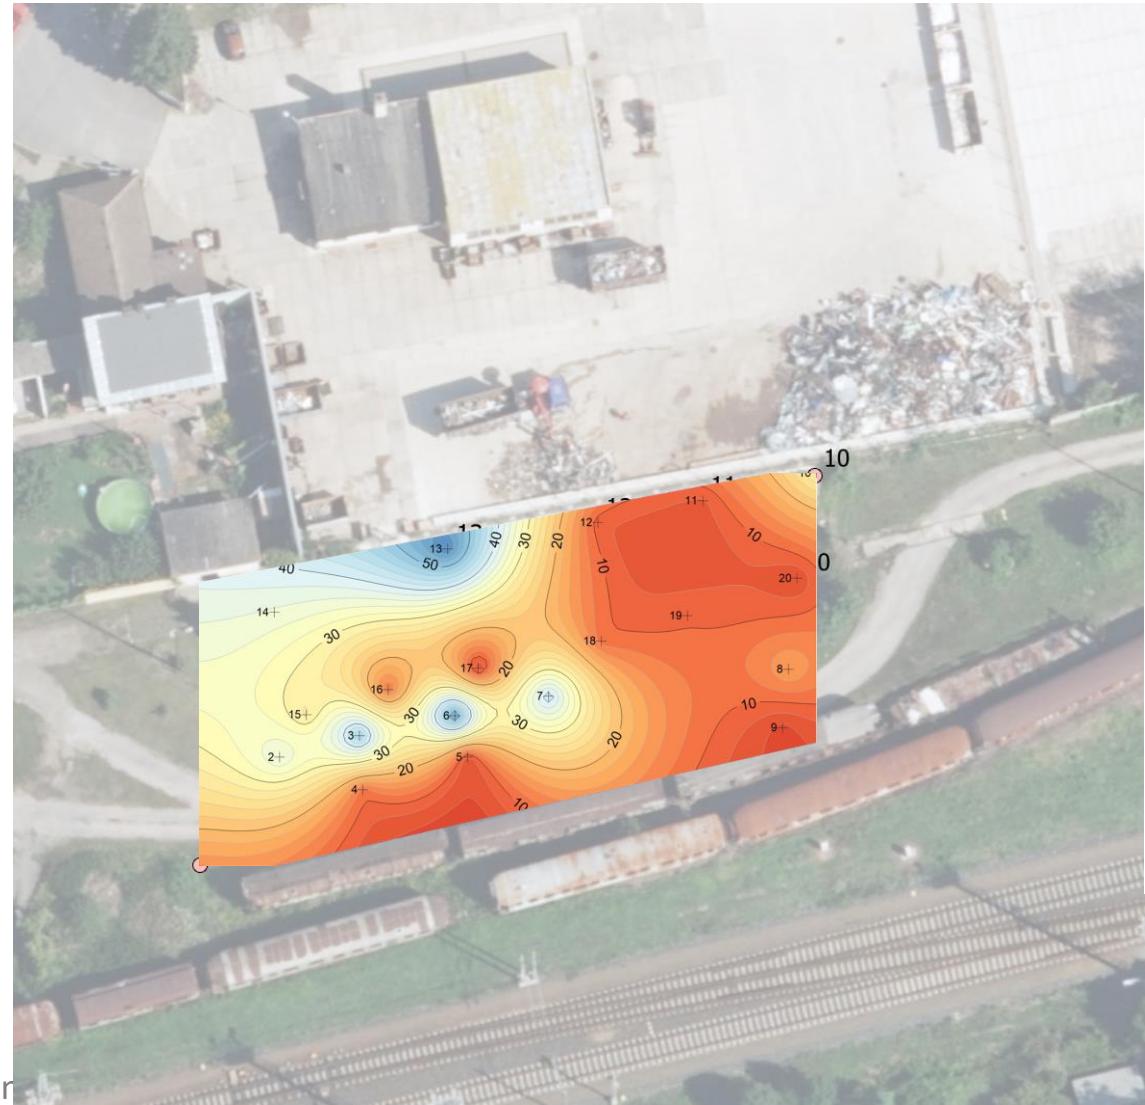
## Radon measuring - Results

12/2024 and 06/2025

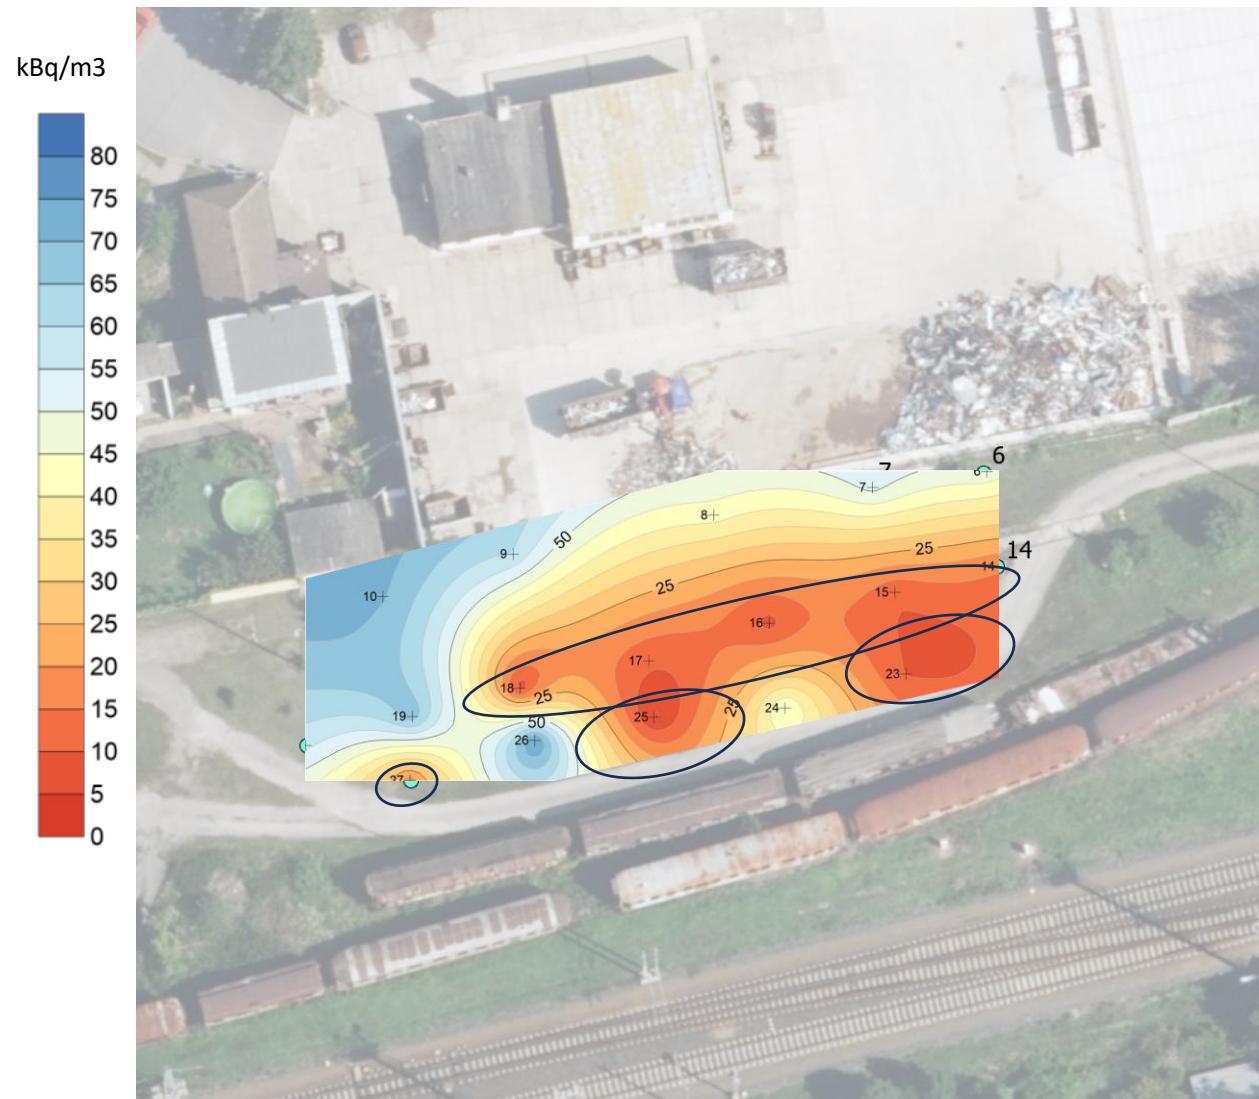
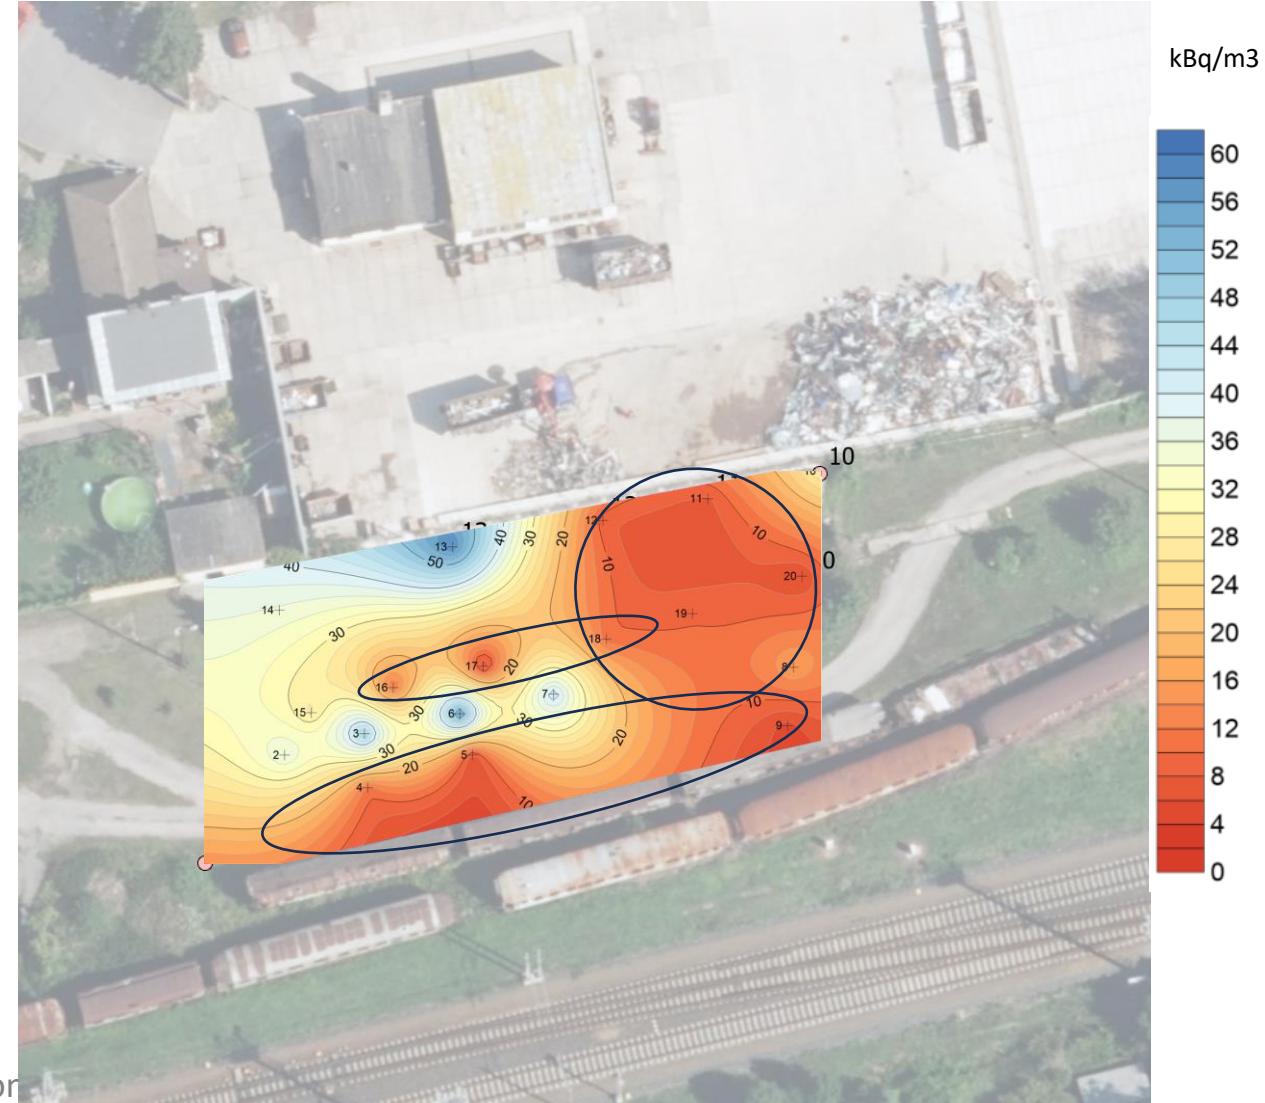
## *Radon measuring - Results*

12/2024 and 06/2025

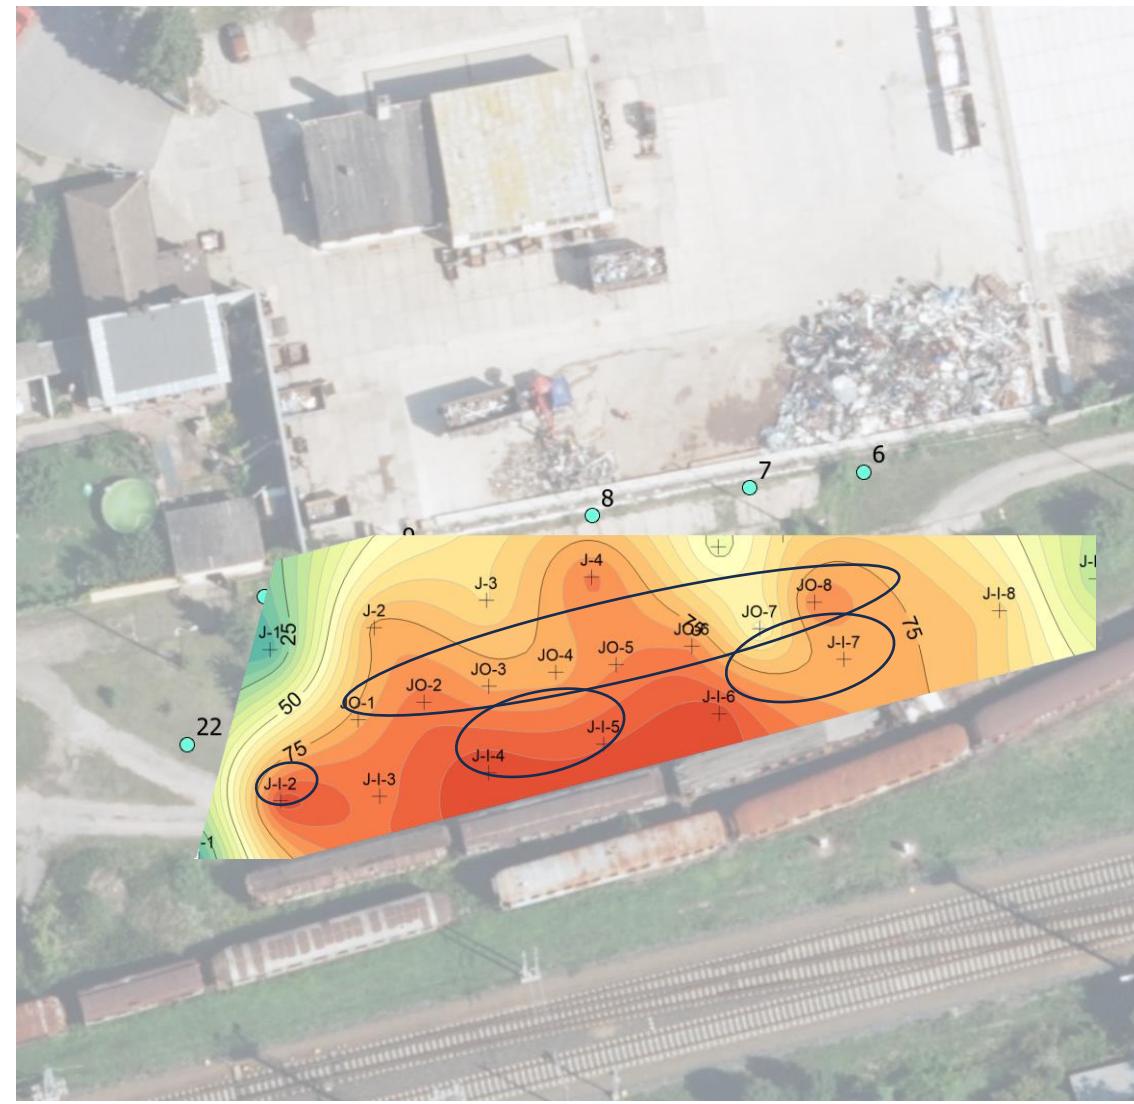
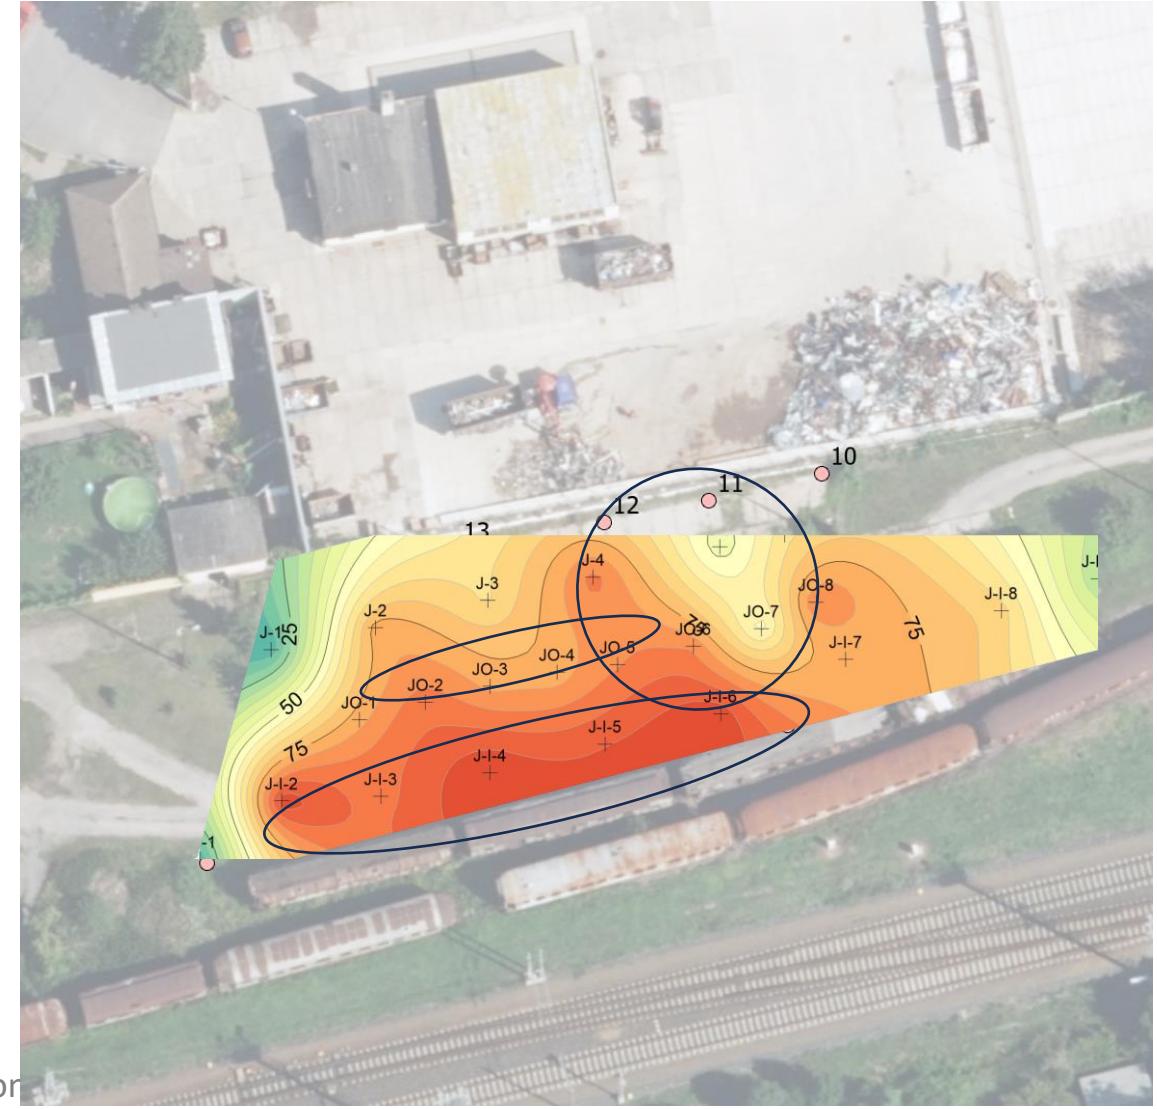
## Radon measuring - Results

12/2024 and 06/2025

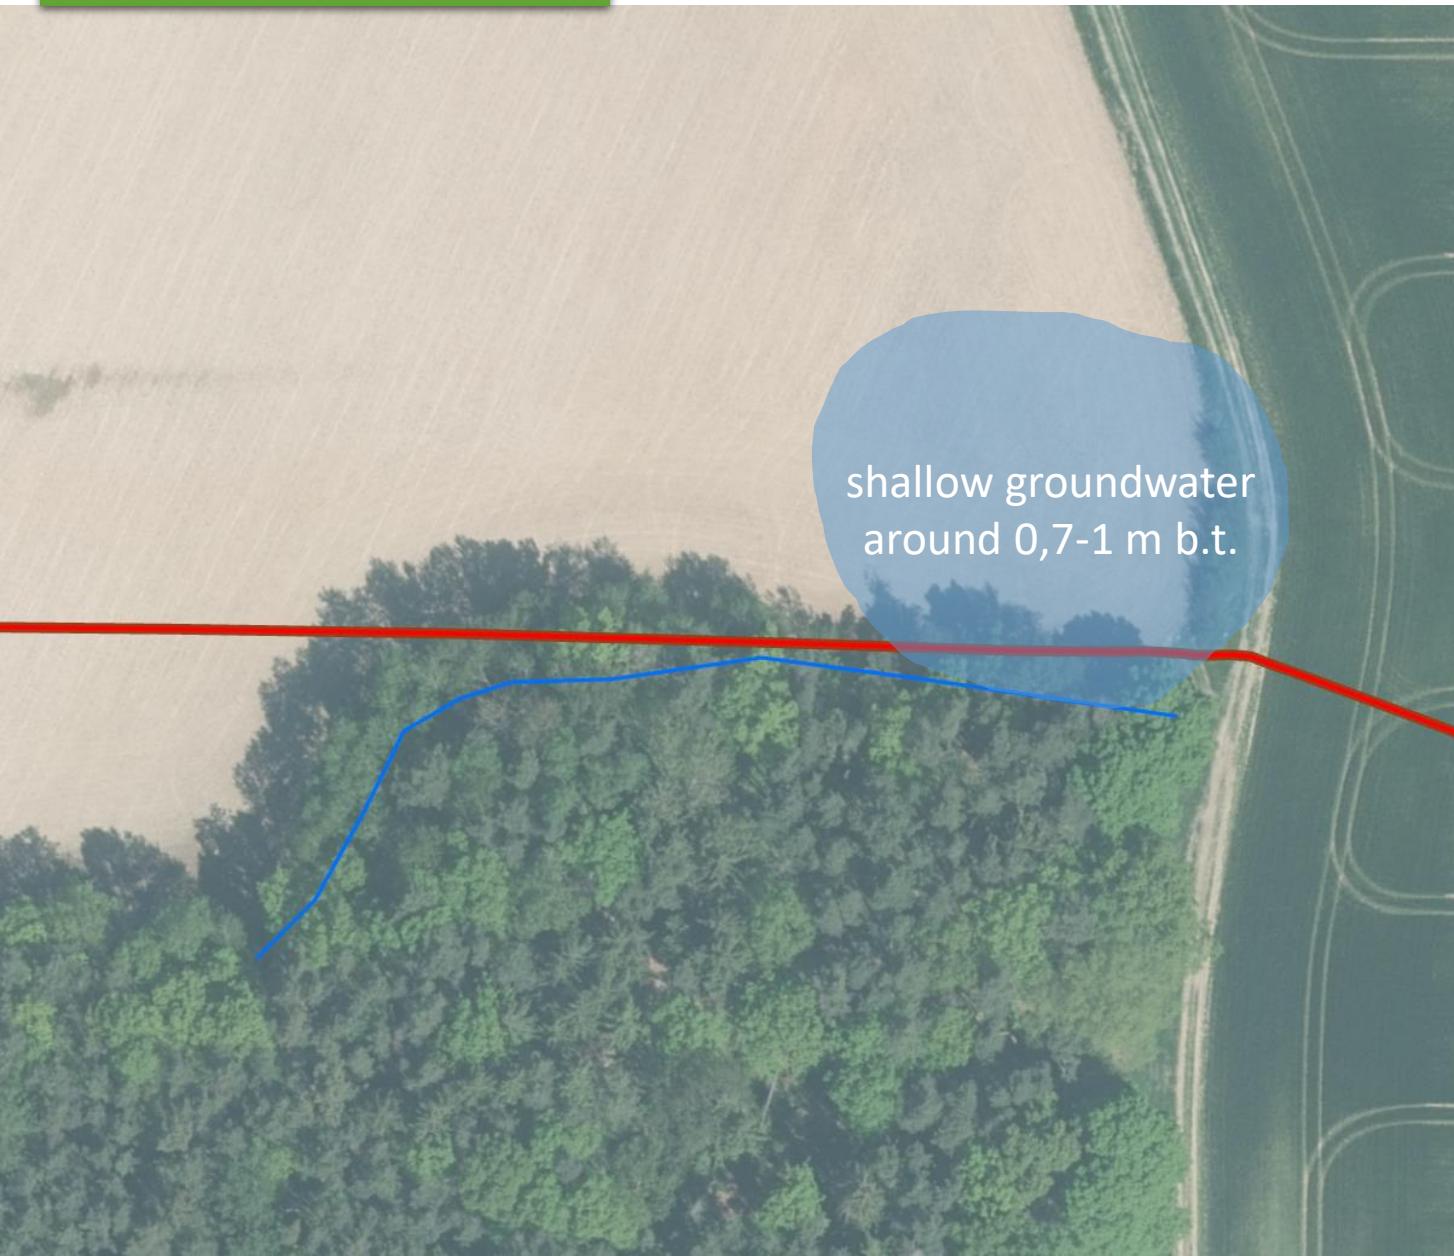
*Bedrock:* biotitic gneiss, strongly weathered in the upper parts

### *Hydrogeology:*

- Fracture aquifer of bedrock with groundwater depth approx. 30 m below ground level
- Quaternary cover represents an overlying insulator
- Local shallow and discontinuous subsurface aquifers with depth 2.6–0.7 m below ground level

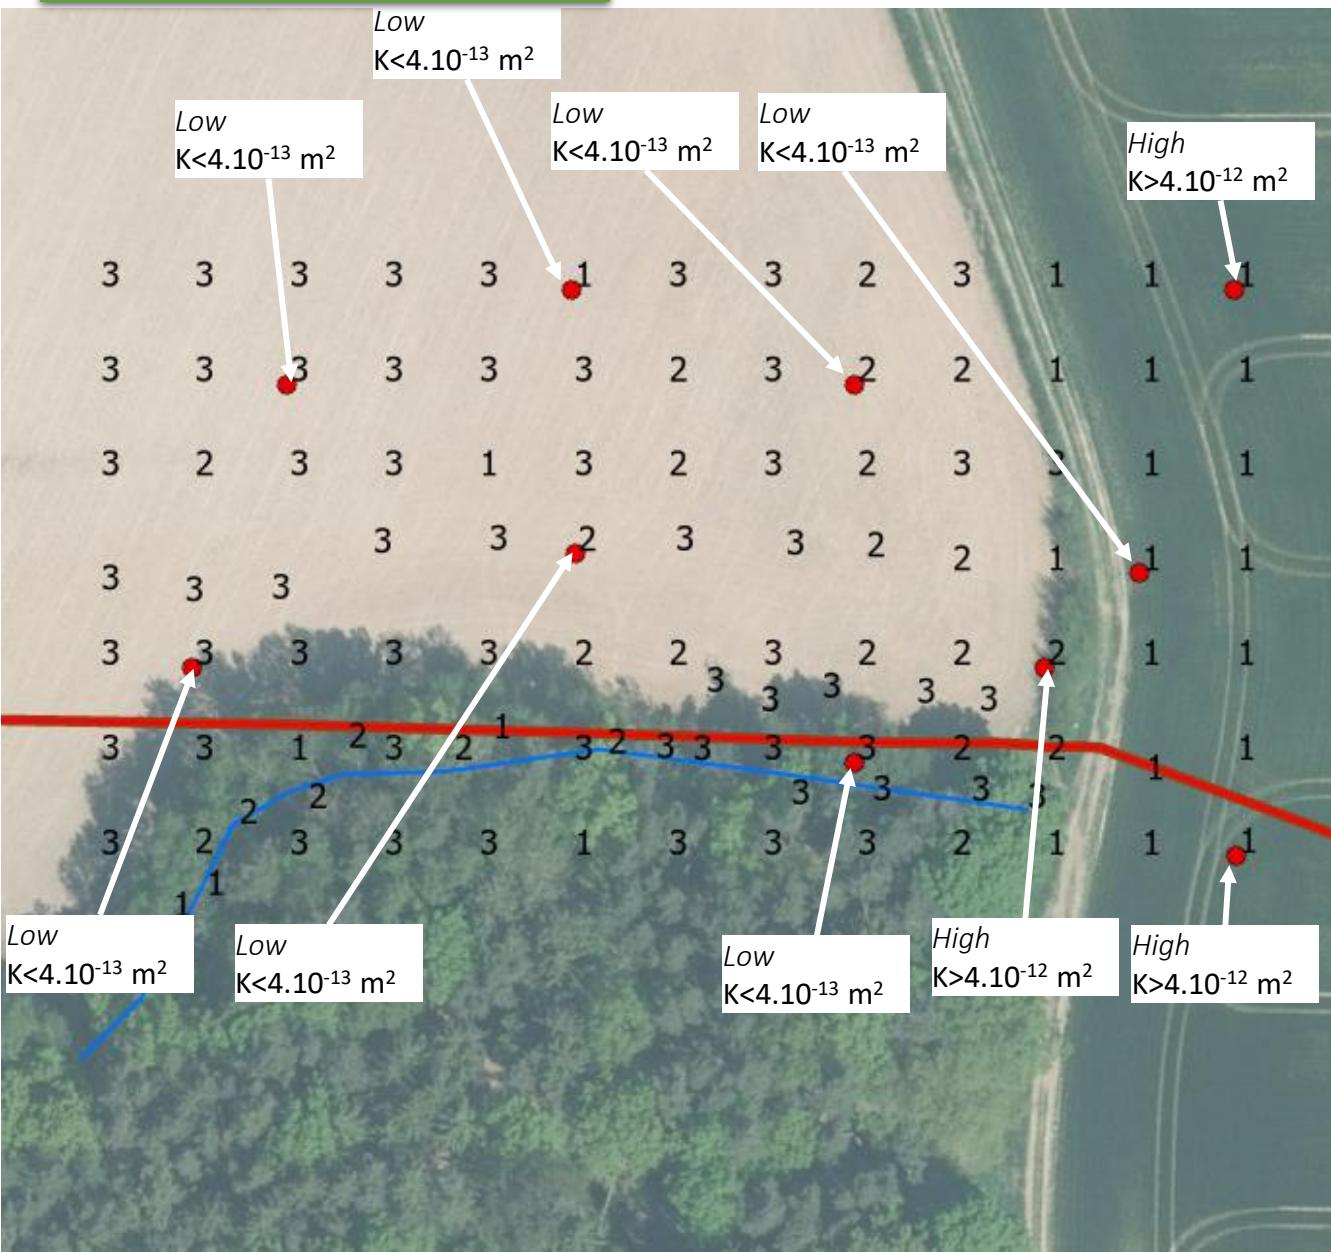
### Soil profile characterisation:

- Agriculture soil
- 0 – 1 m sandy and clay loam

### Dominant soil gas permeability:

- Subjectively during sampling (80 cm): Low

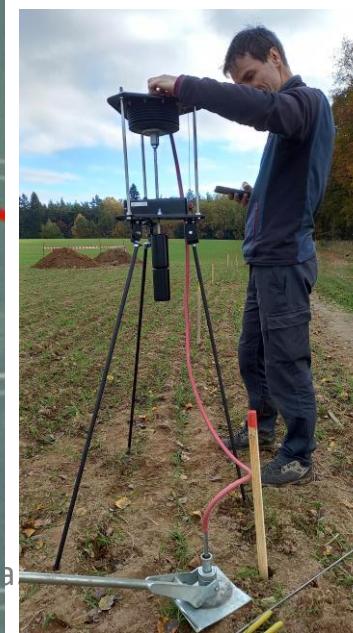
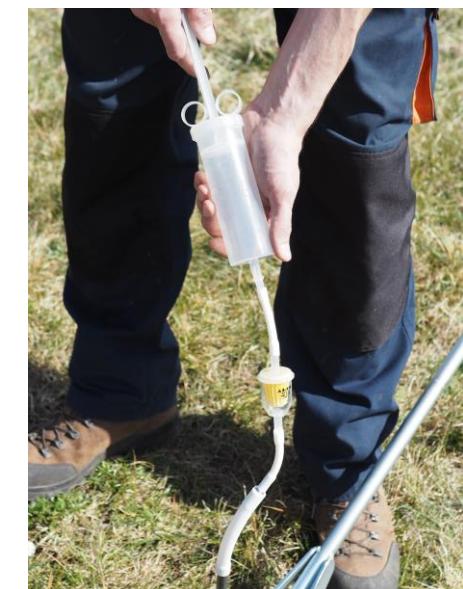
3=Low  
 $K < 4.10^{-13} \text{ m}^2$

2=Medium

1=High  
 $K > 4.10^{-12} \text{ m}^2$

- Measured K by JOK apparatus:  
 10 points

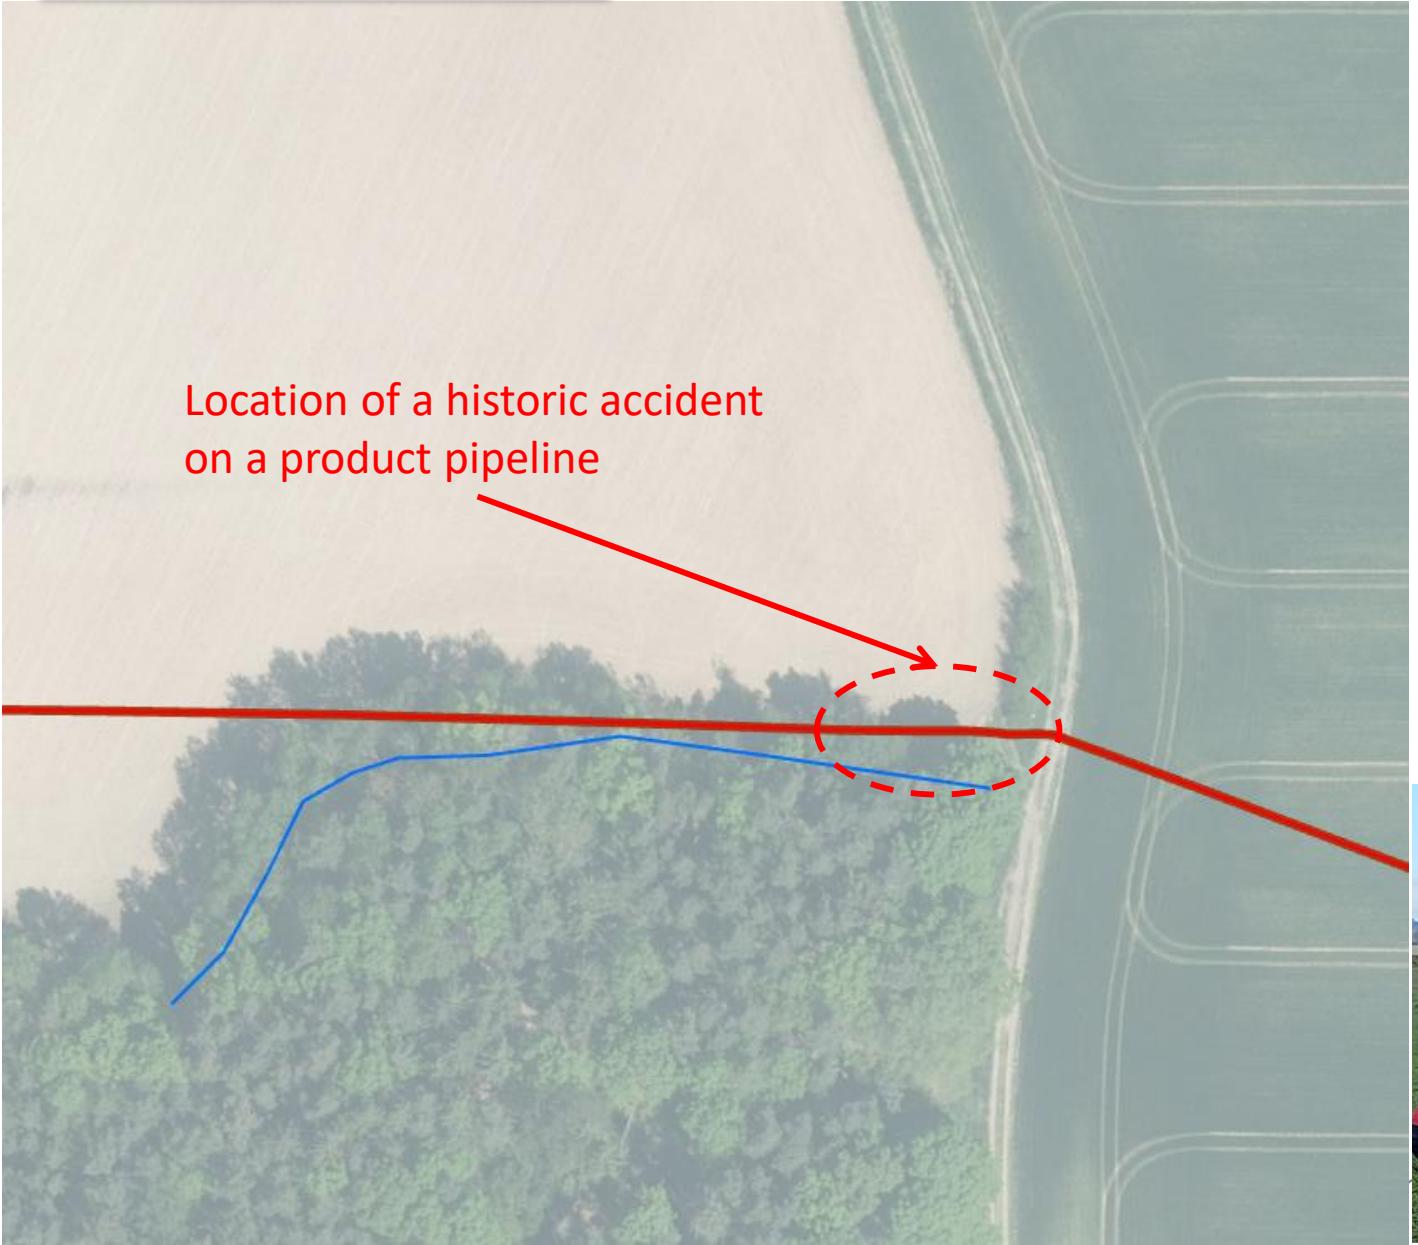
Location of a historic accident  
on a product pipeline

### Contamination data:

- Source of contamination: historical accident on the pipeline before 1990 with fuel leakage (gasoline and diesel) into the subsoil
- Type of contamination: n-alkanes in the range C10-C30, corresponding to Diesel
- Max contamination in soil: C10-C40 8000 mg/kg
- measured phase thickness at the groundwater level: just a thin layer of oil (2025)

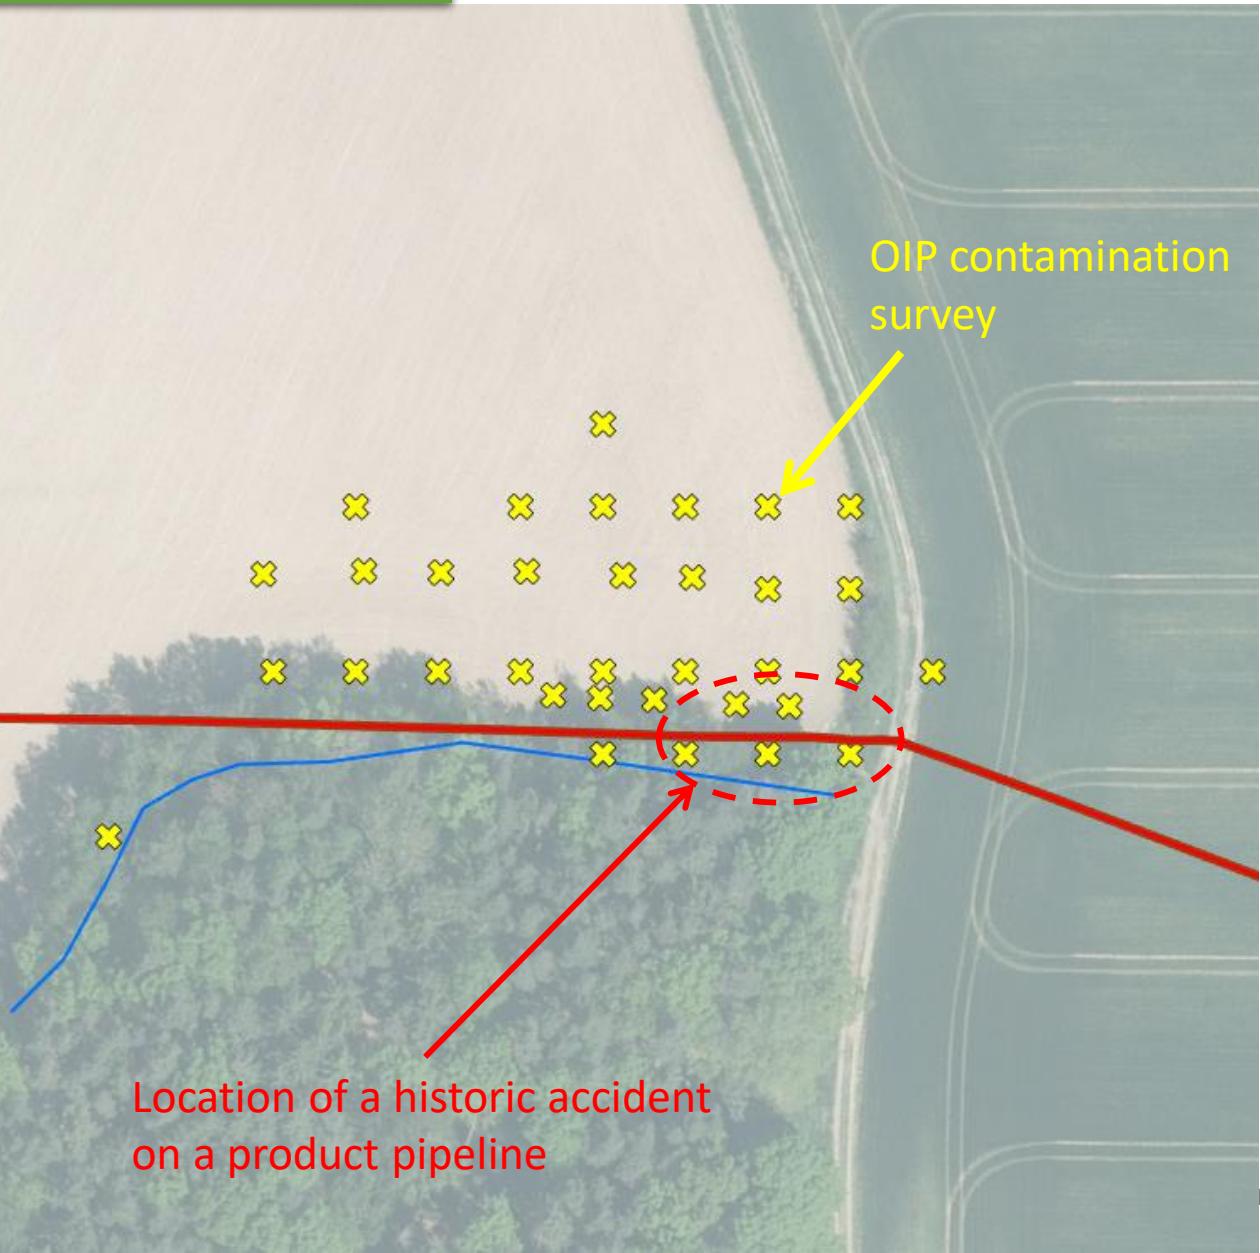
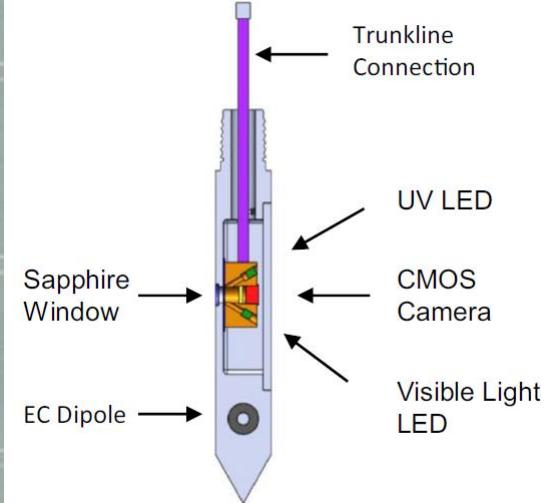
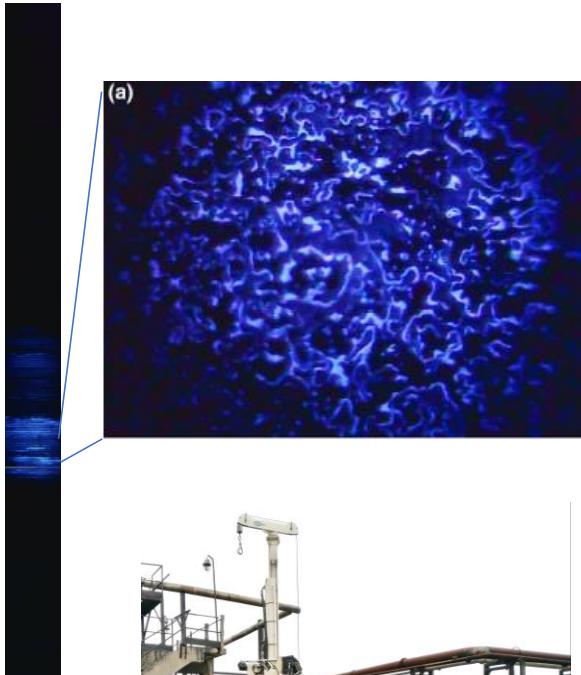
Contamination data:

- Contamination survey using OIP (Optical Image Profiler)

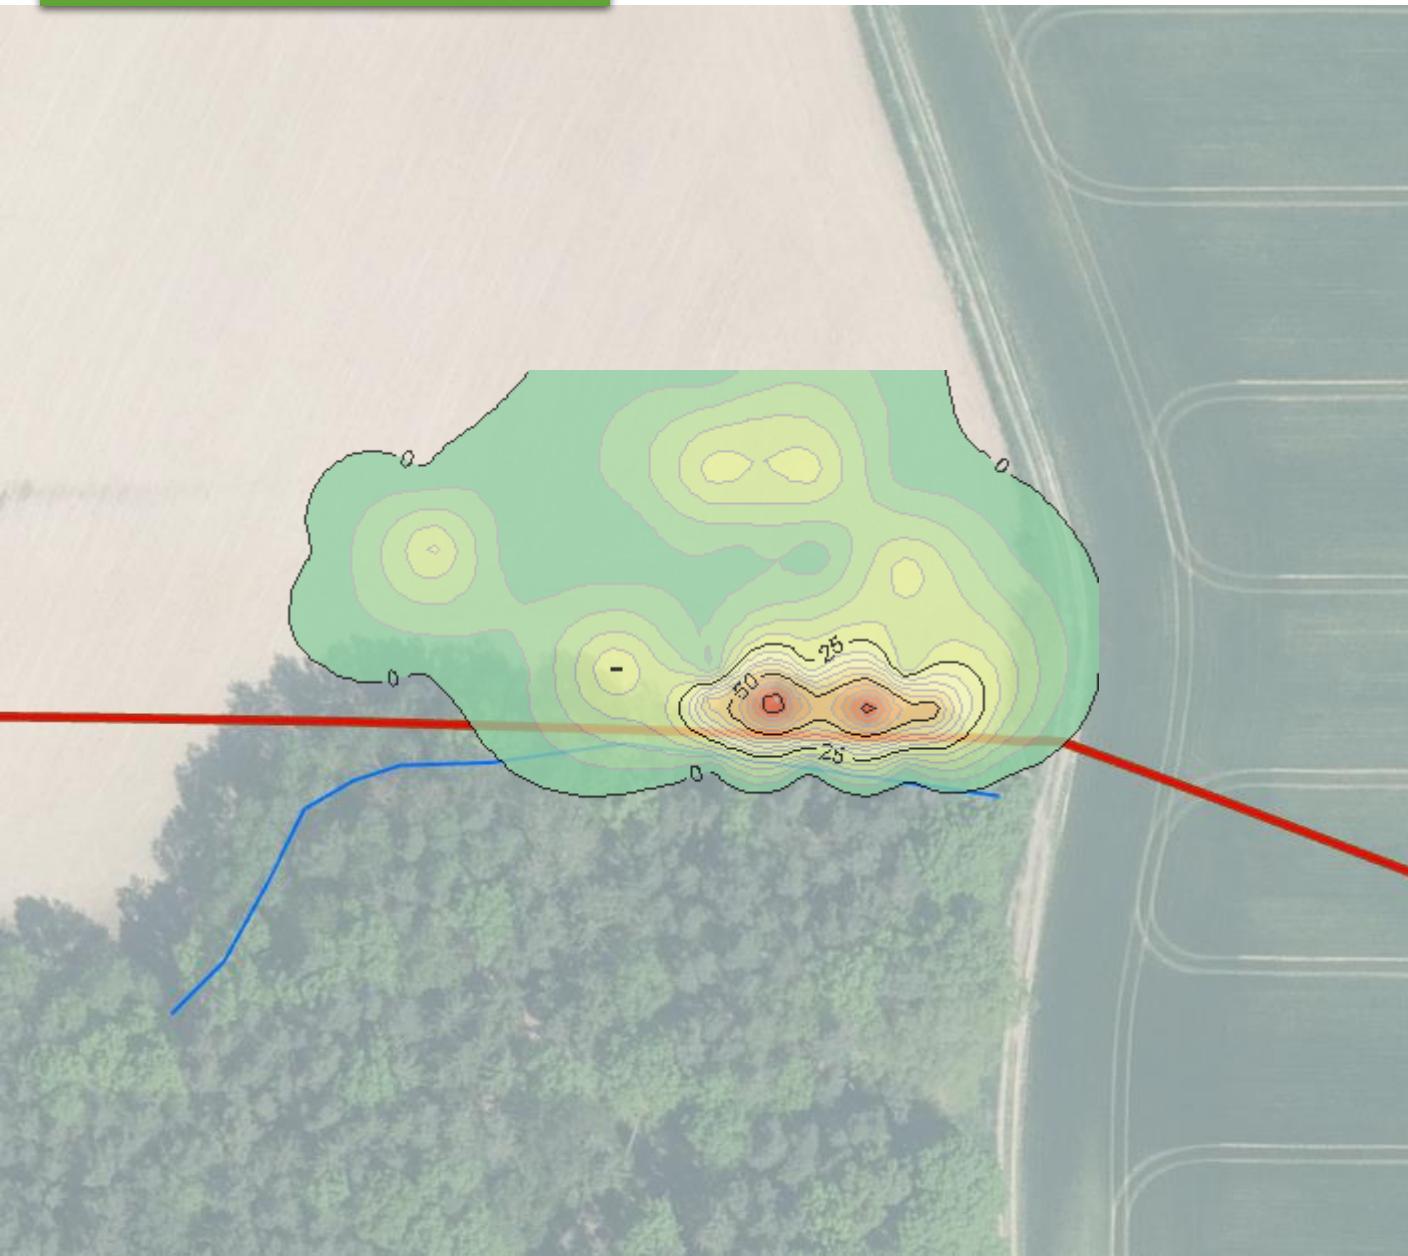
### Contamination data:

- Contamination survey using OIP (Optical Image Profiler)
- Estimated contaminated area: 400-800 m<sup>2</sup>
- Estimated volume of oil product: 400 - 1000 L (max)
- Estimated volume of contaminated soil: 800 m<sup>3</sup> (max)
- Extent and spread of contamination: Oil product fixed to less permeable soil and local shallow aquifer, non-mobile
