# Case studies (RADOIL project pilot sites)

Measurement of radon in soil gas as an indicator of contamination by petroleum substances

RADOIL - Measurement of radon in soil gas as an indicator of contamination by petroleum substances

**Methodology for indirect  
measurement of oil contamination  
using the natural tracer Rn**

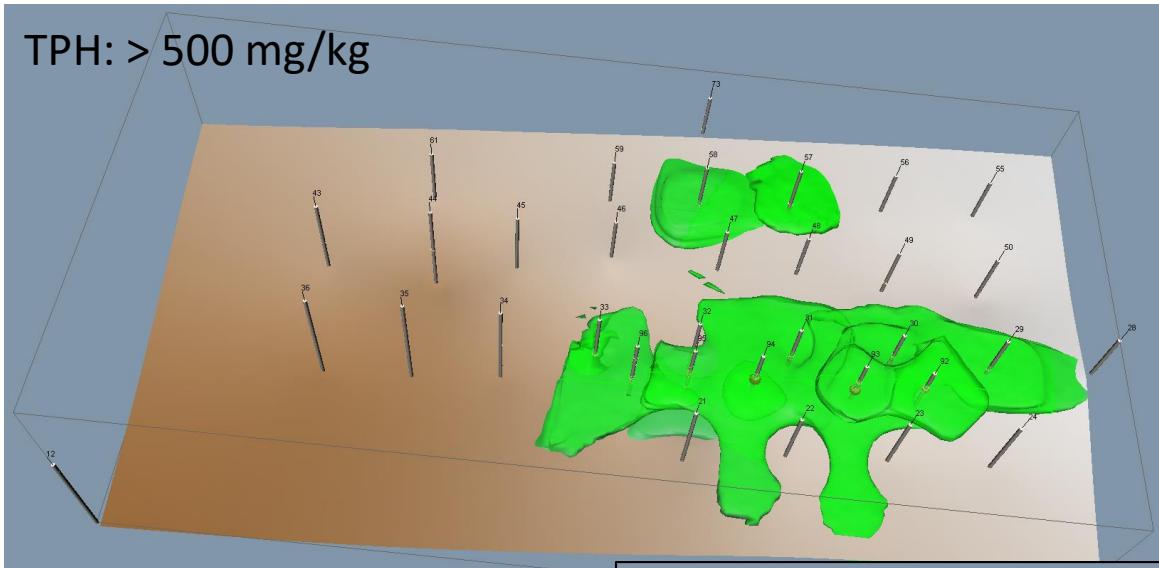
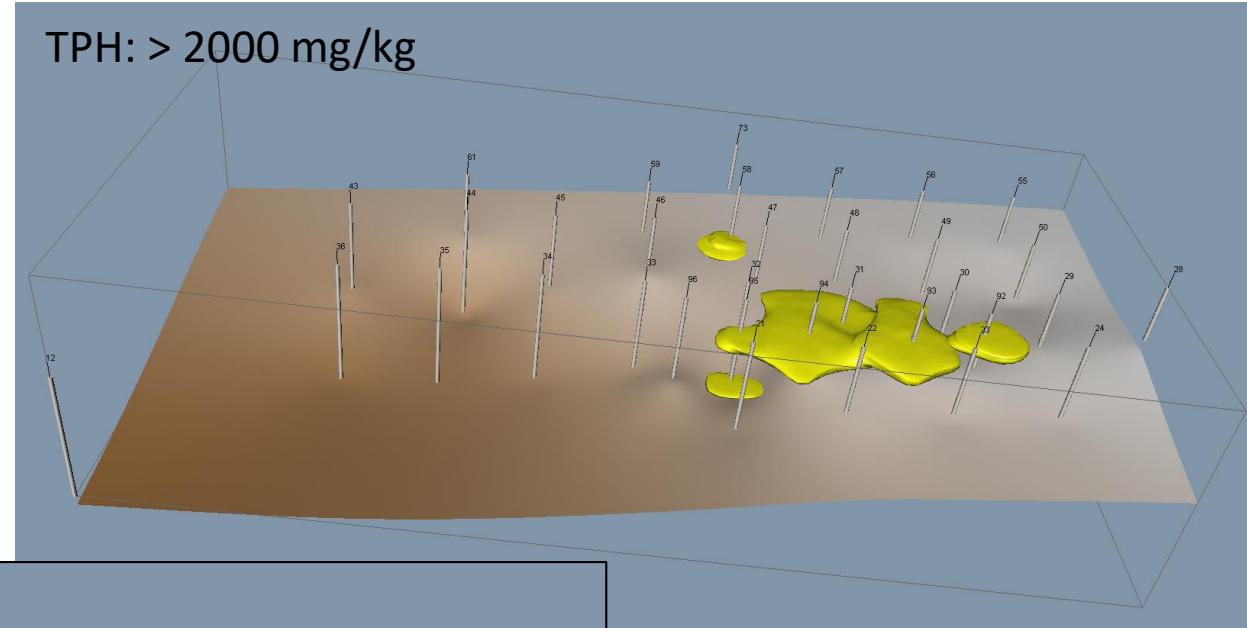
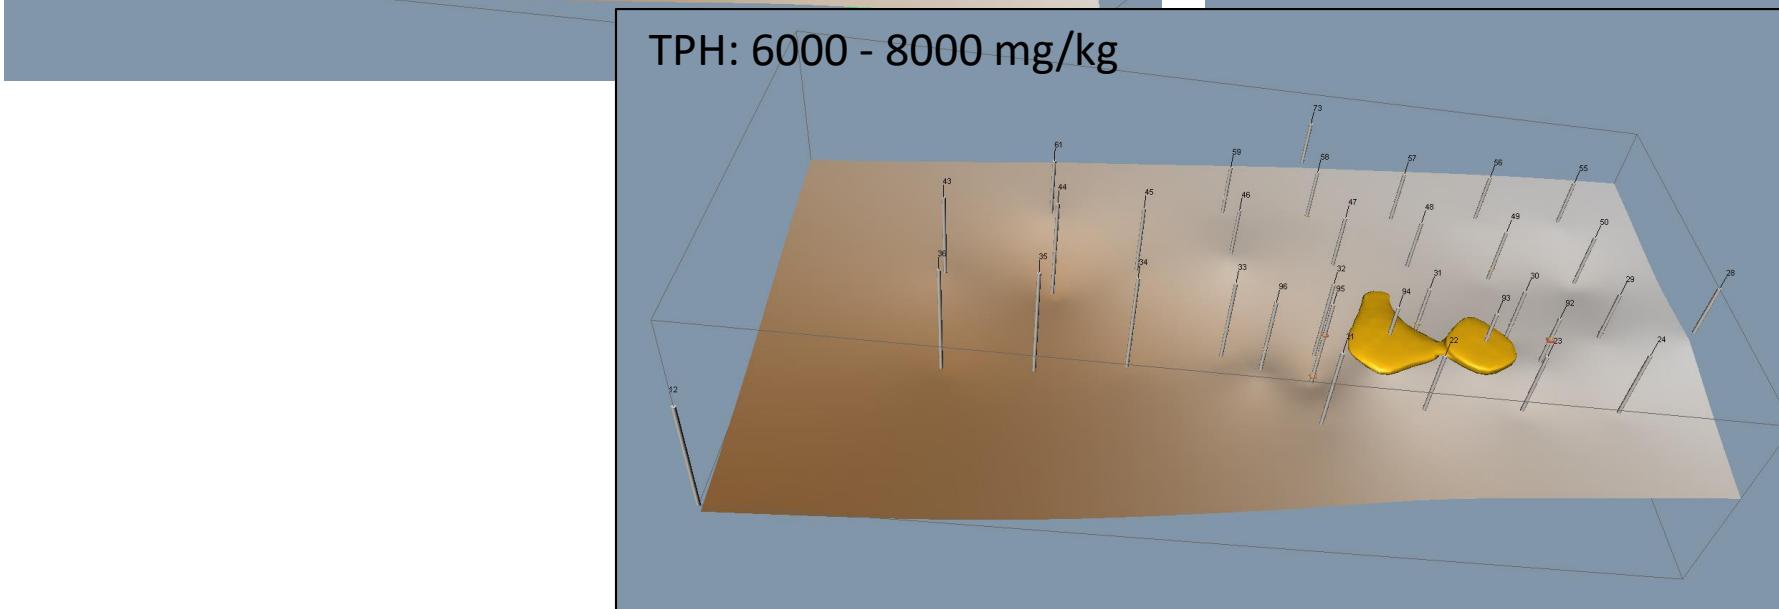
### Contamination data:

- Contamination survey using OIP (Optical Image Profiler)

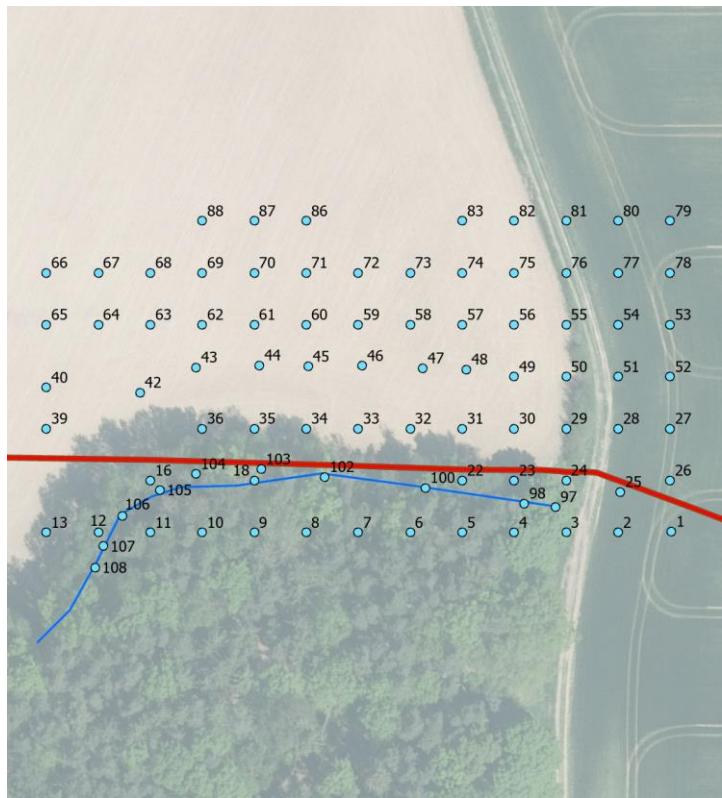
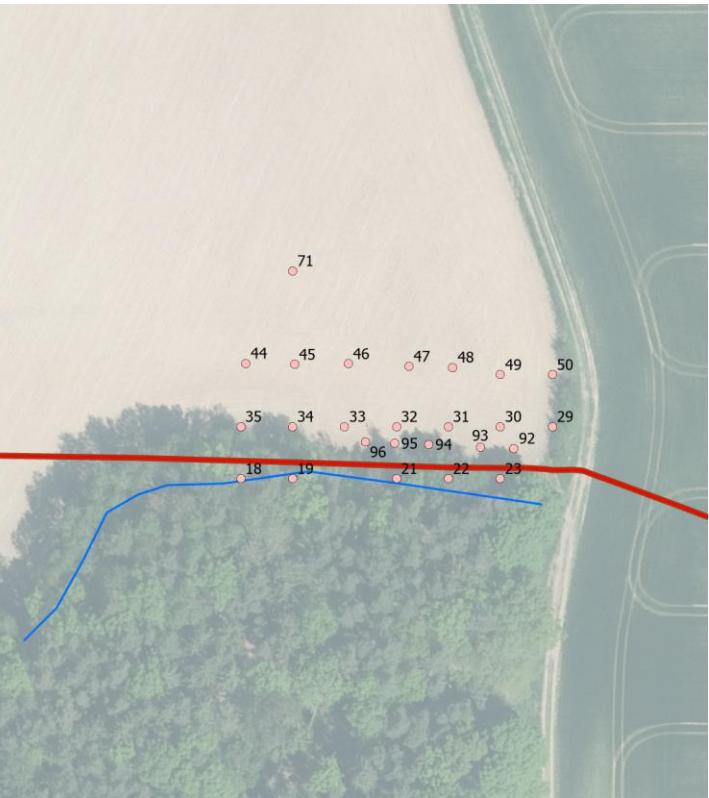
### Methodology of Radon measuring:

- 2 campaigns: 10/2024 and 11/2024
- Soil gas sampling in 50-80 cm and 30 cm depth
- Volumetric activity of Rn-222 (Bq/m<sup>3</sup>)
- RM-2 device with ionization chamber
- 87 and 25 sampling points, 10 x 10 m grid
- Outdoor temperature: 10°C and 5°C

87/25 sampling points

Average activity

103 x 174 kBq/m<sup>3</sup>

Coef. of variation

63% x 60%

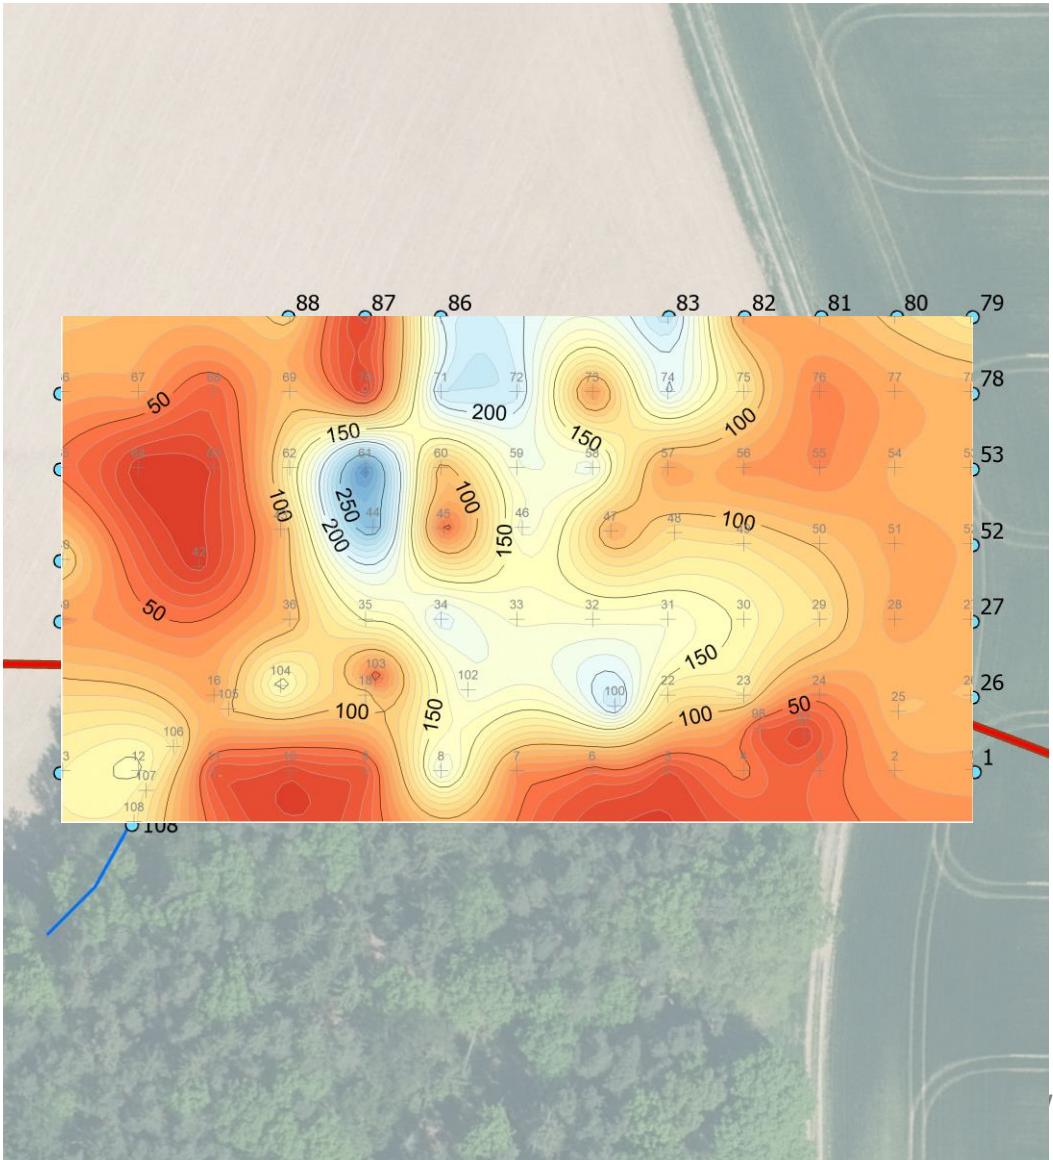
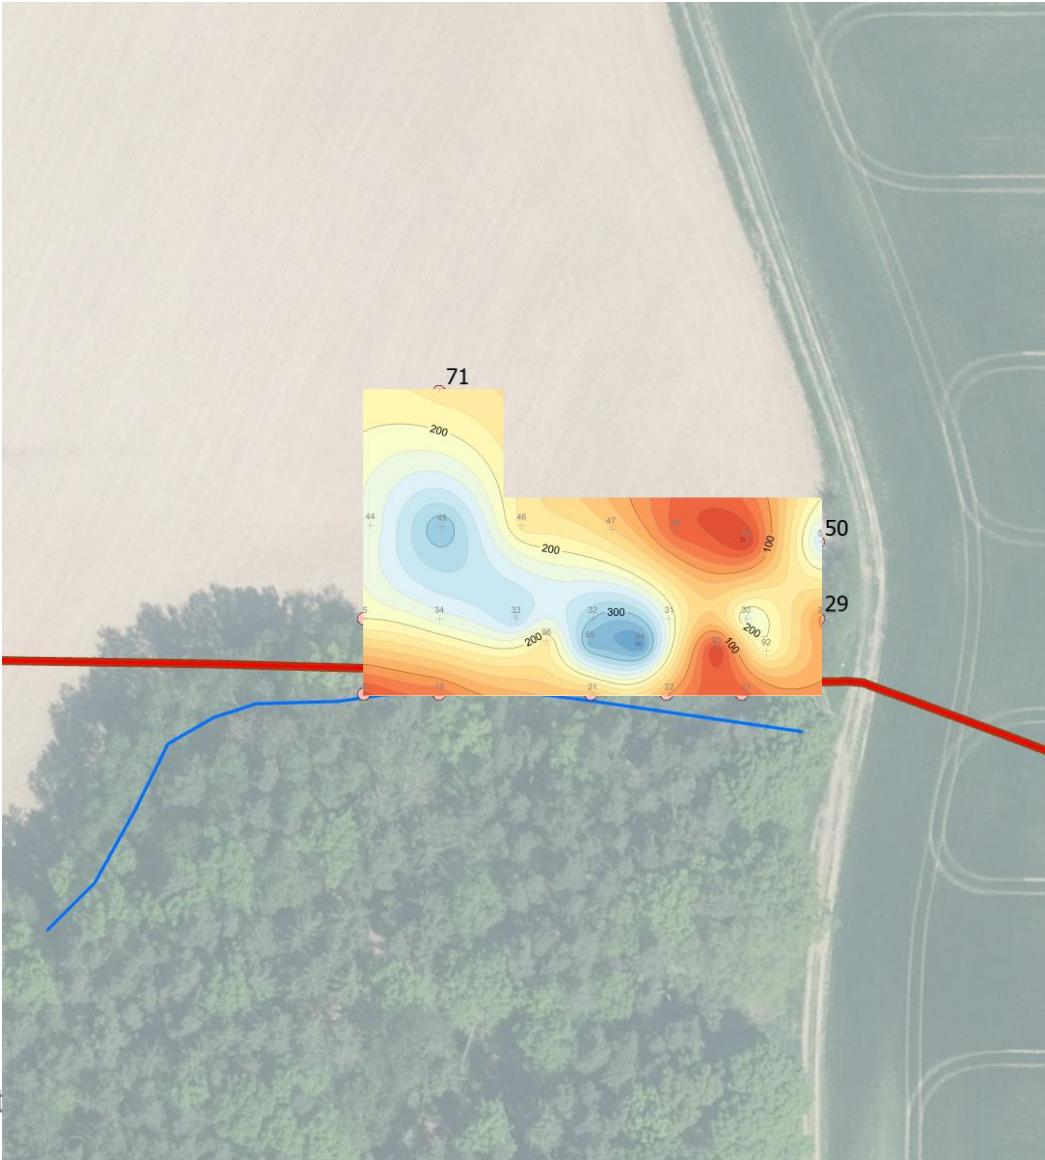
## Radon measuring - Results

10/2024 and 11/2024

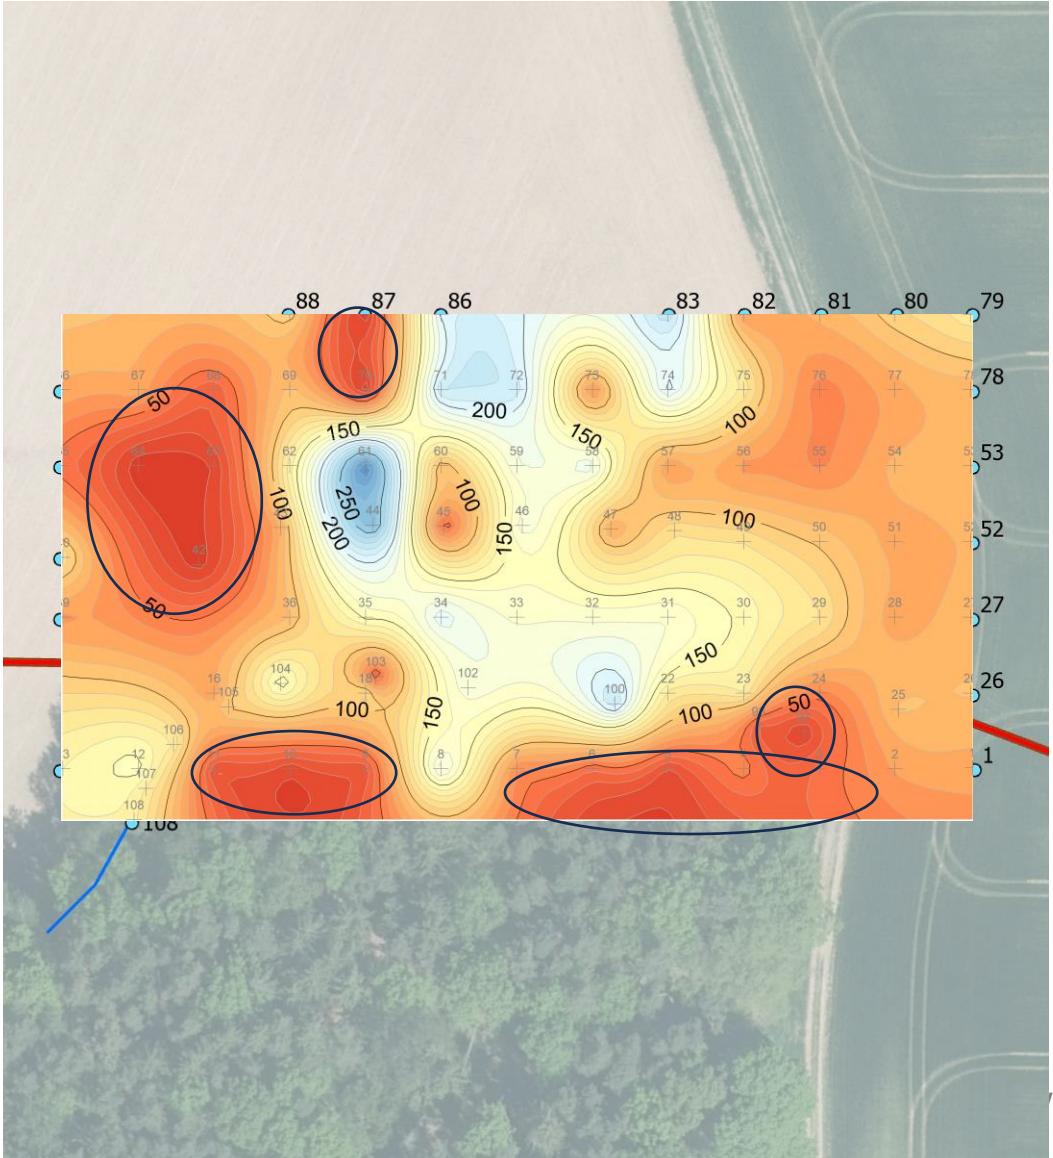
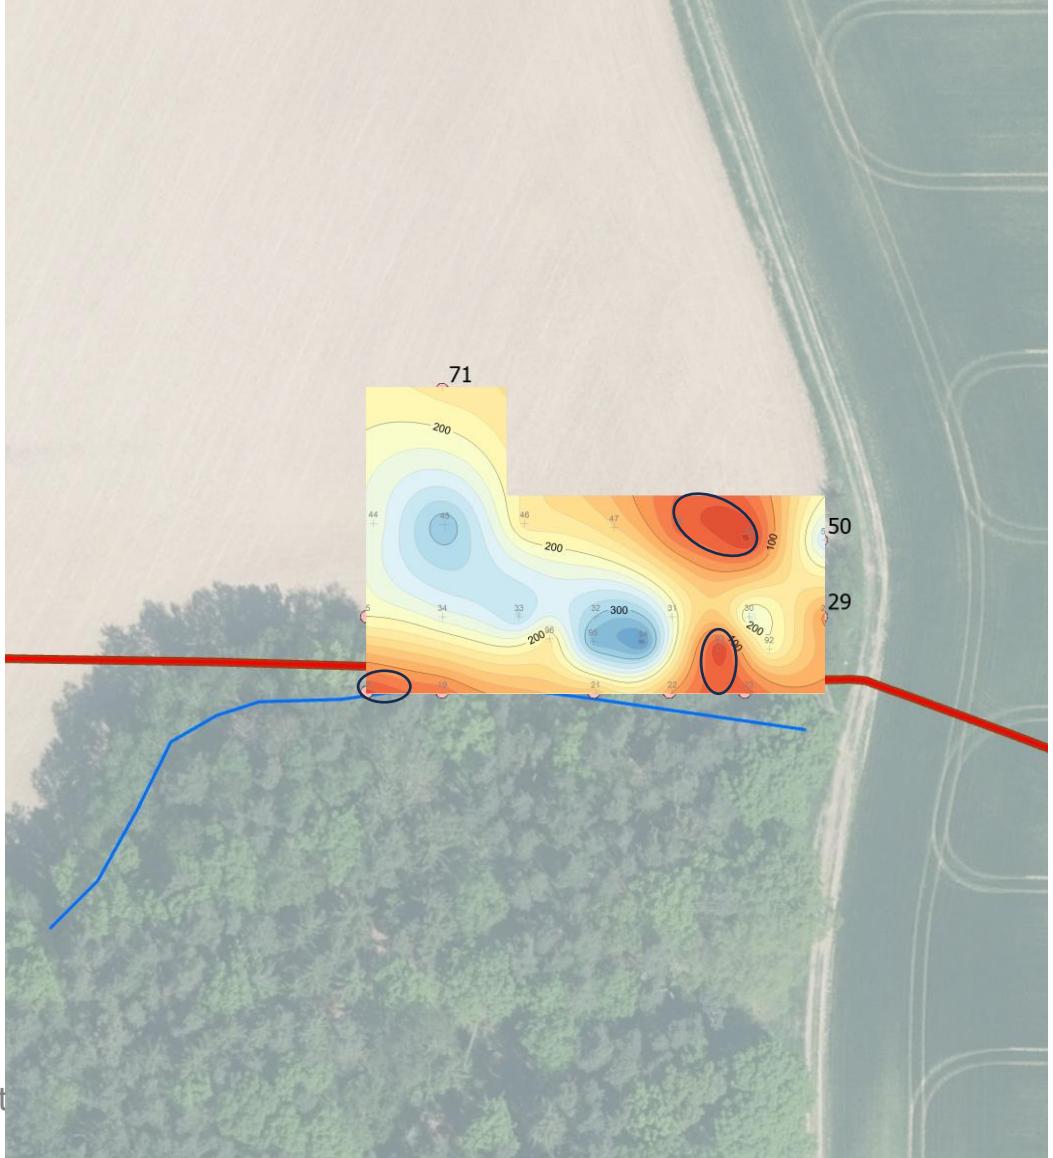
## Radon measuring - Results

10/2024 and 11/2024

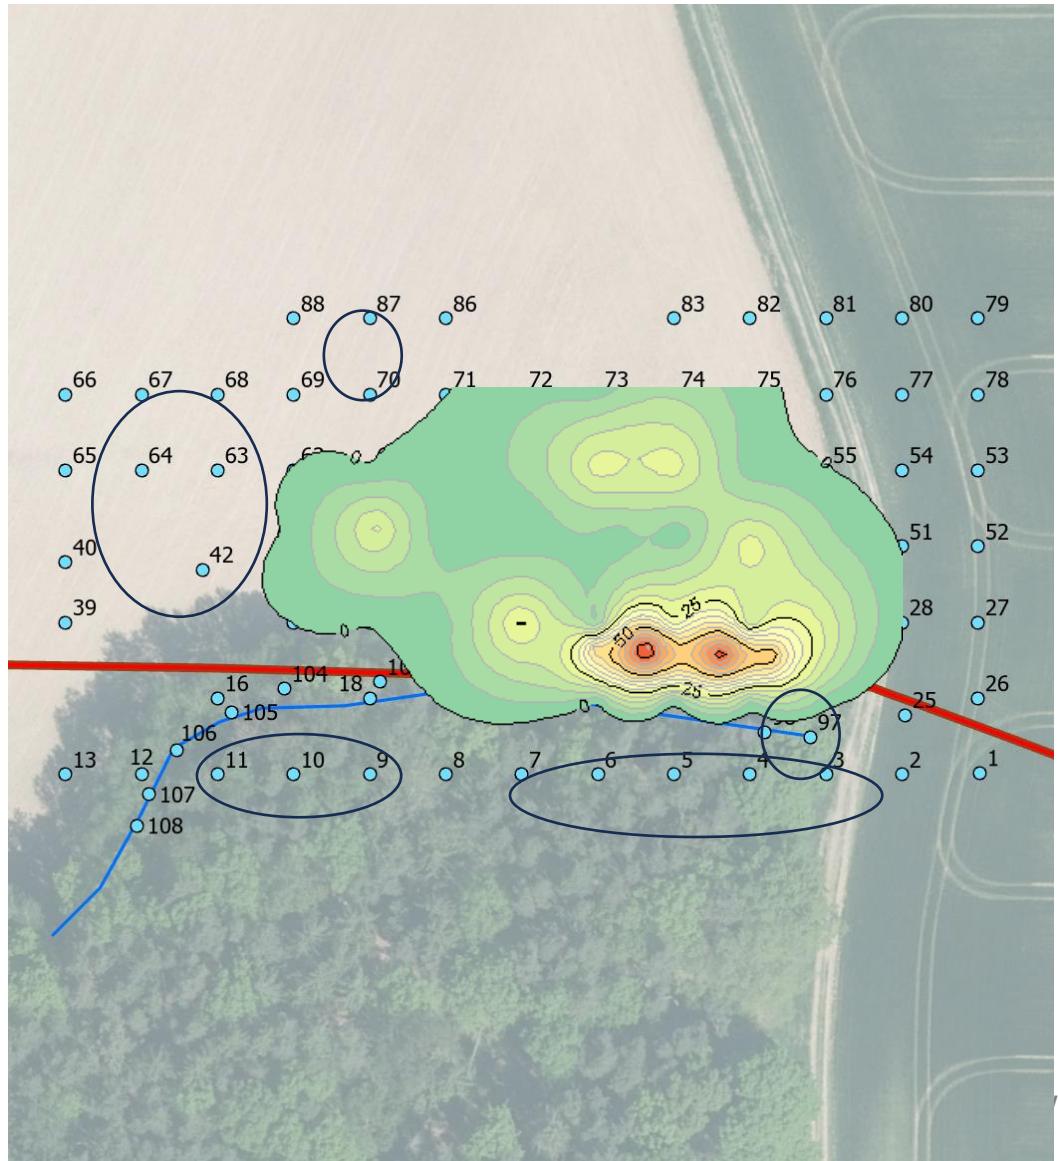
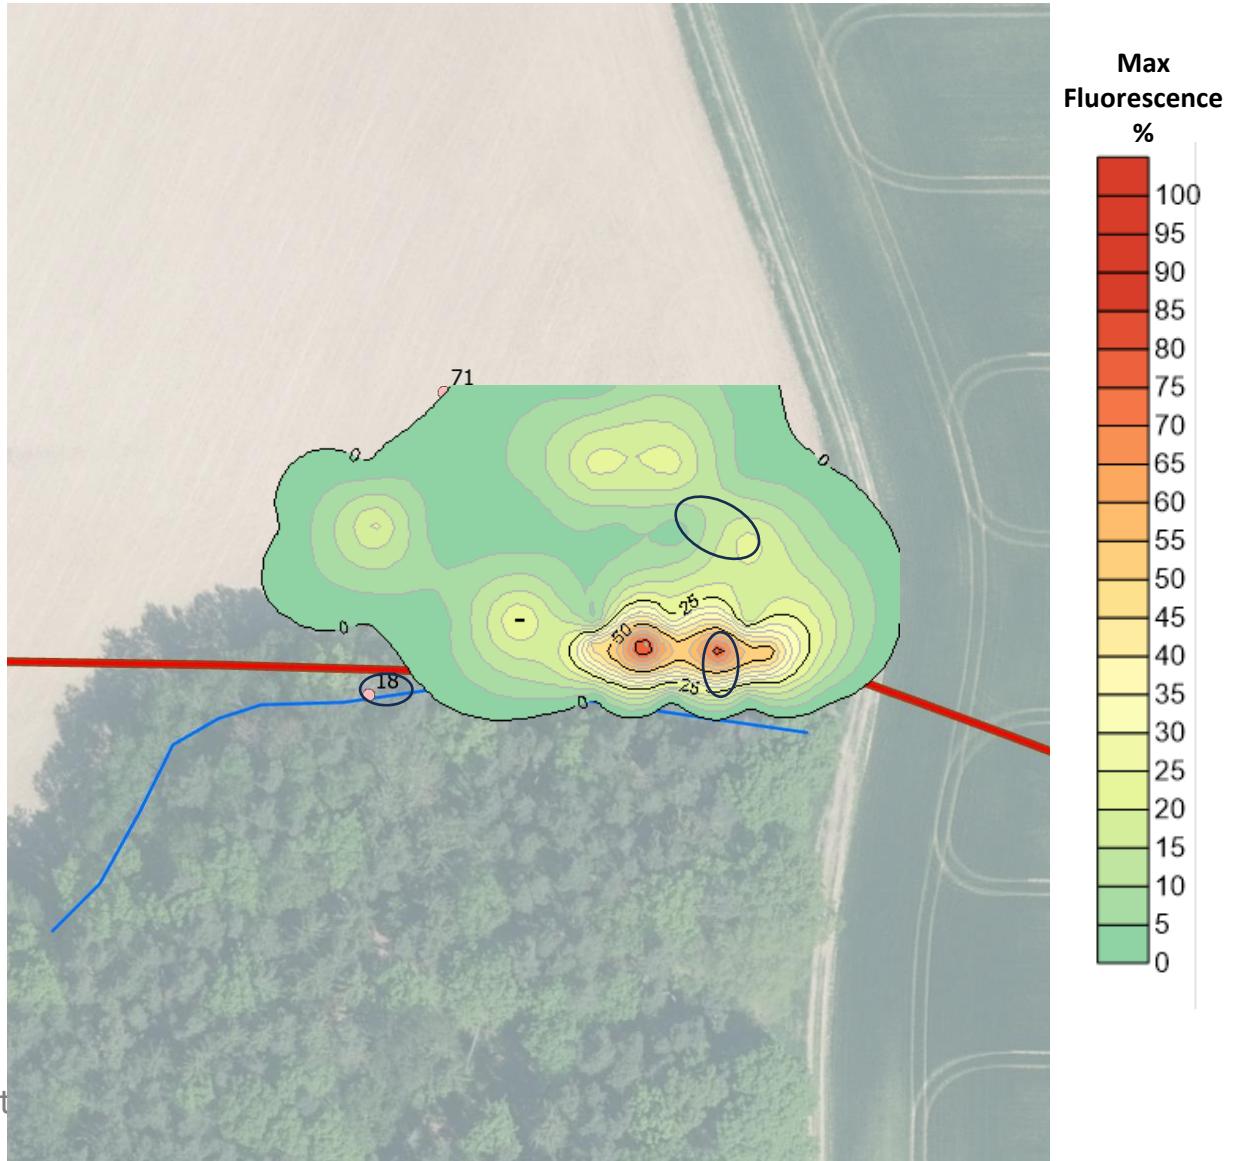
## Radon measuring - Results

10/2024 and 11/2024
